# Access Compliance Report

## Public Rights-of-Way

### (Curb Ramps)

Intersection ID: 10034710	Main Street: POINDEXTER_DR	Cross Street: N/A	Location:	N
ADA ID: A74599871BEE	Ramp Type: Perp	Initial Pass/Fail: Fail	Overall Compliance: No	Severity Score: 12.5
Codes/Mitigation Info/Possible Solution		Field Measurements/Component Compliance

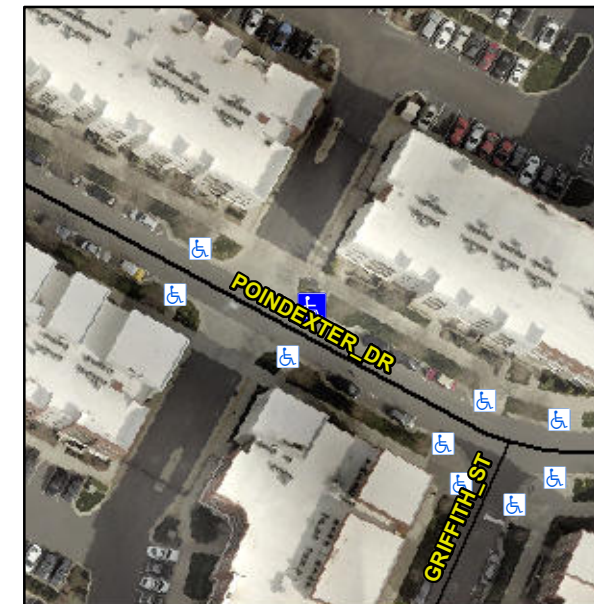
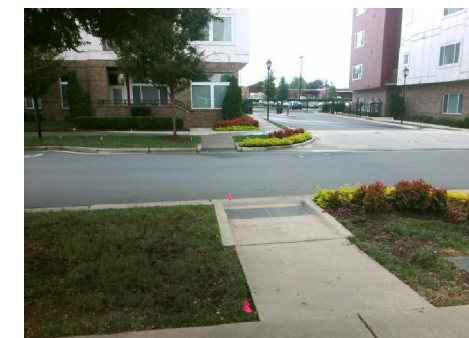
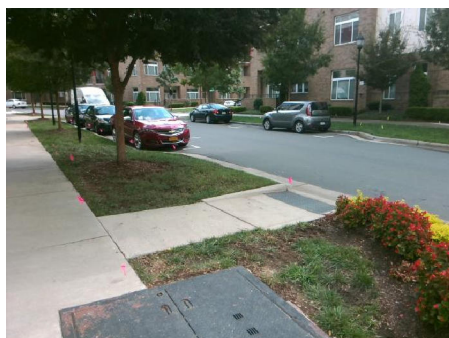
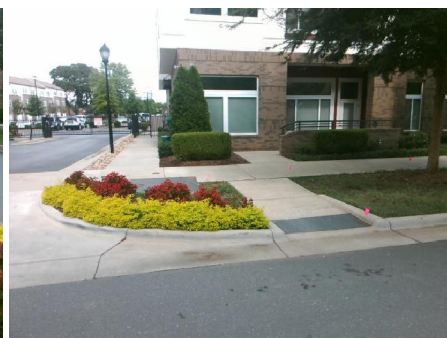
Compliance	Description	Data	Compliance	Description	Data
N/A	Ramp Length (in)	72.0	No	Ramp Slope (%)	9.1
Yes	Ramp Width (in)	59.0	Yes	Ramp XSlope (%)	0.7
N/A	Flare Type LT	N/A	N/A	Flare Type RT	N/A
N/A	Flare Slope LT (%)	N/A	N/A	Flare Slope RT (%)	N/A
N/A	Flare Traversable LT?	N/A	N/A	Flare Traversable RT?	N/A
N/A	Landing Length (in)	N/A	N/A	DWS Provided?	N/A
N/A	Landing Width (in)	N/A	N/A	DWS Contrast?	N/A
N/A	Landing Slope (%)	N/A	N/A	DWS Length (in)	N/A
N/A	Landing X Slope (%)	N/A	N/A	DWS Full Width?	N/A
N/A	Landing Curb? (Y/N)	N/A	N/A	DWS Offset (in)	N/A
N/A	Shared Landing?	N/A			
N/A	Gutter Ponding?	N/A	N/A	Gutter Slope (%)	N/A
N/A	Gutter Lip Ht (in)	N/A	N/A	Gutter X Slope (%)	N/A
N/A	Painted X Walk1?	No	N/A	Painted X Walk2?	N/A
	X Walk 1 Direction	To SW		X Walk 2 Direction	N/A
N/A	X Walk 1 Width (in)	N/A	N/A	X Walk 2 Width (in)	N/A
	X Walk 1 Slope (%)	0.6		X Walk 2 Slope (%)	N/A
	X Walk 1 X Slope (%)	0.5		X Walk 2 X Slope (%)	N/A

N/A	Ramp inside XWalk1?	N/A	N/A	Ramp inside XWalk2?	N/A
	Road Slope (%)	N/A	N/A	Clear Space?	N/A
	Road X Slope (%)	N/A	N/A	Clear Space to XWalk (in)	N/A
N/A	Any Obstructions?	N/A	N/A	Storm Grate/Utility Hazard?	N/A
	Obstruction Type			Storm Grate/Utility Type	
		N/A			N/A
			Yes	Surface Condition? (G/P)	Good

**Remove & Replace Entire Ramp.**

**R304.2.2**
