# Access Compliance Report

## Public Rights-of-Way

### (Curb Ramps)

Intersection ID: 22144	Main Street: MORNING_DALE_RD	Cross Street: SARDIS_FOREST_DR	Location: SE
ADA ID: A748C421A94D	Ramp Type: Perp	Initial Pass/Fail: Fail	Overall Compliance: No
Severity Score: 37.5			
Codes/Mitigation Info/Possible Solution		Field Measurements/Component Compliance

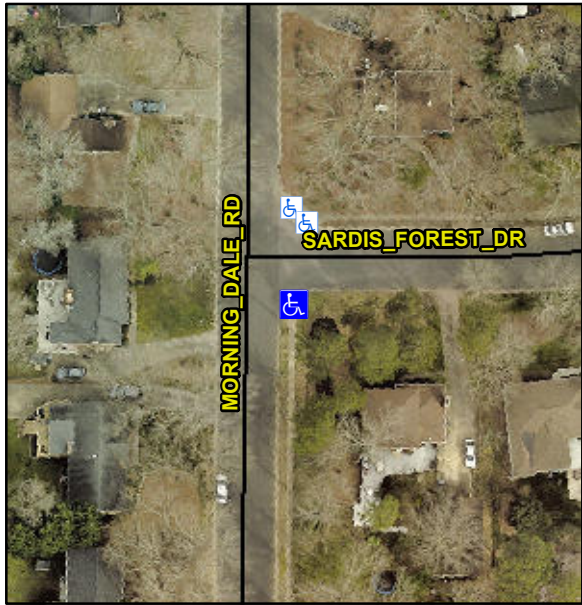
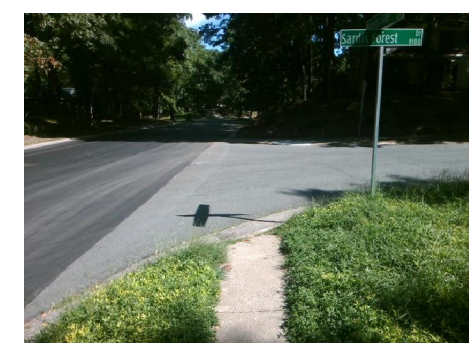
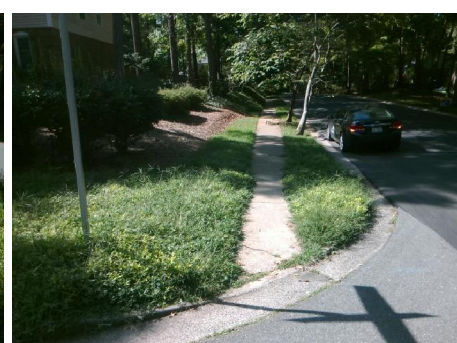
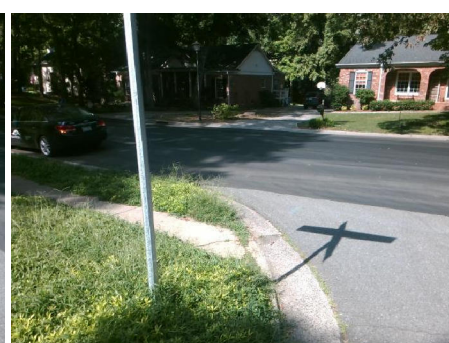
Possible Solutions:		Compliance		Description	Data	Compliance		Description	Data
	Remove & Replace Entire Ramp.		N/A	Ramp Length (in)	48.0	No	Ramp Slope (%)	12.8		
			Yes	Ramp Width (in)	48.0	No	Ramp XSlope (%)	5.3		
			N/A	Flare Type LT	N/A	N/A	Flare Type RT	N/A		
			N/A	Flare Slope LT (%)	N/A	N/A	Flare Slope RT (%)	N/A		
			N/A	Flare Traversable LT?	N/A	N/A	Flare Traversable RT?	N/A		
			N/A	Landing Length (in)	N/A	N/A	DWS Provided?	N/A		
			N/A	Landing Width (in)	N/A	N/A	DWS Contrast?	N/A		
			N/A	Landing Slope (%)	N/A	N/A	DWS Length (in)	N/A		
			N/A	Landing X Slope (%)	N/A	N/A	DWS Full Width?	N/A		
Surveyor Notes:  N/A   PROW/ADA:  R304.2.2, R304.5.3		N/A	Landing Curb? (Y/N)	N/A	N/A	DWS Offset (in)	N/A			
		N/A	Shared Landing?	N/A						
		N/A	Gutter Ponding?	N/A	N/A	Gutter Slope (%)	N/A			
		N/A	Gutter Lip Ht (in)	N/A	N/A	Gutter X Slope (%)	N/A			
		N/A	Painted X Walk1?	No	N/A	Painted X Walk2?	N/A

X Walk 1 Direction	To NE		X Walk 2 Direction	N/A			
		N/A	X Walk 1 Width (in)	N/A	N/A	X Walk 2 Width (in)	N/A			
			X Walk 1 Slope (%)	4.5		X Walk 2 Slope (%)	N/A			
			X Walk 1 X Slope (%)	1.7		X Walk 2 X Slope (%)	N/A			
		N/A	Ramp inside XWalk1?	N/A	N/A	Ramp inside XWalk2?	N/A			
			Road Slope (%)	N/A	N/A	Clear Space?	N/A			
			Road X Slope (%)	N/A	N/A	Clear Space to XWalk (in)	N/A			
		N/A	Any Obstructions?	N/A	N/A	Storm Grate/Utility Hazard?	N/A			
			Obstruction Type			Storm Grate/Utility Type				
					N/A		N/A			
					Yes	Surface Condition? (G/P)	Good
