Access Compliance Report

Public Rights-of-Way

(Curb Ramps)

Intersection ID: 5609	Main Street: HAMILTON_CR	Cross Street: SUNSET_RD	Location: NW
ADA ID: A74B0661D552	Ramp Type: Perp	Initial Pass/Fail: Fail	Overall Compliance: No
Severity Score: 21.25			
Codes/Mitigation Info/Possible Solution		Field Measurements/Component Compliance

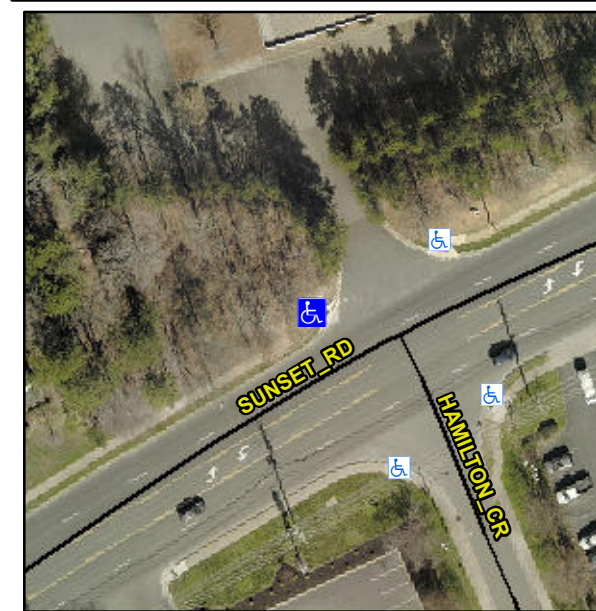
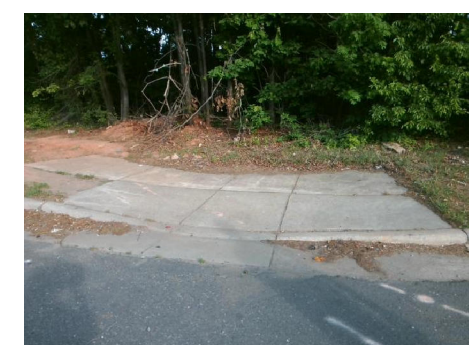
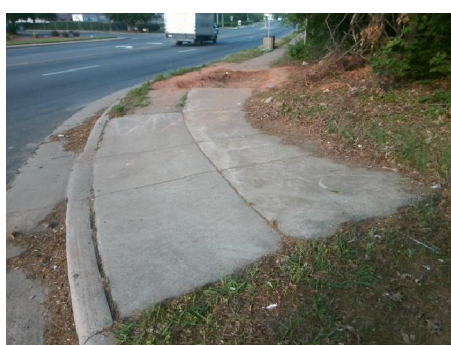
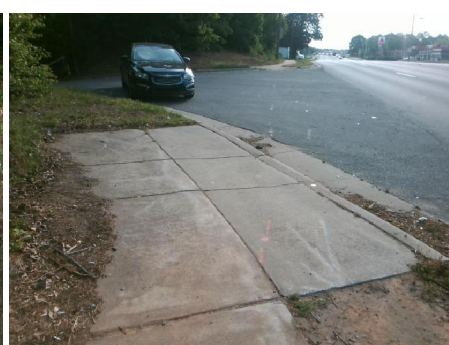
Compliance	Description	Data	Compliance	Description	Data
N/A	Ramp Length (in)	49.5	Yes	Ramp Slope (%)	6.9
No	Ramp Width (in)	42.0	No	Ramp XSlope (%)	5.4
N/A	Flare Type LT	N/A	N/A	Flare Type RT	N/A
N/A	Flare Slope LT (%)	N/A	N/A	Flare Slope RT (%)	N/A
N/A	Flare Traversable LT?	N/A	N/A	Flare Traversable RT?	N/A
N/A	Landing Length (in)	N/A	N/A	DWS Provided?	N/A
N/A	Landing Width (in)	N/A	N/A	DWS Contrast?	N/A
N/A	Landing Slope (%)	N/A	N/A	DWS Length (in)	N/A
N/A	Landing X Slope (%)	N/A	N/A	DWS Full Width?	N/A
N/A	Landing Curb? (Y/N)	N/A	N/A	DWS Offset (in)	N/A
N/A	Shared Landing?	N/A			
N/A	Gutter Ponding?	N/A	N/A	Gutter Slope (%)	N/A
N/A	Gutter Lip Ht (in)	N/A	N/A	Gutter X Slope (%)	N/A
N/A	Painted X Walk1?	No	N/A	Painted X Walk2?	N/A
	X Walk 1 Direction	To S		X Walk 2 Direction	N/A
N/A	X Walk 1 Width (in)	N/A	N/A	X Walk 2 Width (in)	N/A
	X Walk 1 Slope (%)	2.4		X Walk 2 Slope (%)	N/A
	X Walk 1 X Slope (%)	2.4		X Walk 2 X Slope (%)	N/A

N/A	Ramp inside XWalk1?	N/A	N/A	Ramp inside XWalk2?	N/A
	Road Slope (%)	N/A	N/A	Clear Space?	N/A
	Road X Slope (%)	N/A	N/A	Clear Space to XWalk (in)	N/A
N/A	Any Obstructions?	N/A	N/A	Storm Grate/Utility Hazard?	N/A
	Obstruction Type			Storm Grate/Utility Type	
		N/A			N/A
			Yes	Surface Condition? (G/P)	Good

Possible Solutions:

Remove & Replace Entire Ramp.

R304.5.1, R304.5.3

Total Cost: \$ 1850.00
