# Access Compliance Report

## Public Rights-of-Way

### (Curb Ramps)

| Intersection ID: 46371 | Main Street: SIR_CHARLES_PL | Cross Street: STRONVAR_HOUSE_LN | Location: SE |

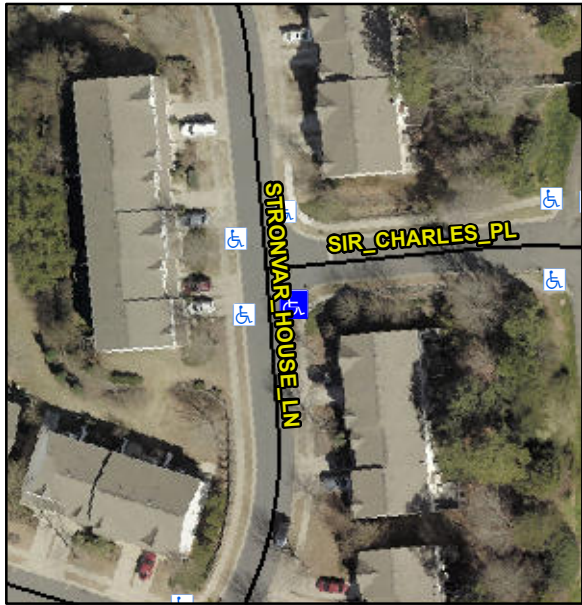
| ADA ID: A74F1327FD4A | Ramp Type: PerpDiag | Initial Pass/Fail: Fail | Overall Compliance: No |
| Severity Score: 33.75 | | | |

| | Not Found, R304.5.1, R304.2.2, R304.5.3 | | | |

| Compliance | Description | Data | Compliance | Description | Data |
|---|---|---|---|---|---|
| N/A | Ramp Length (in) | 49.0 | No | Ramp Slope (%) | 8.7 |
| No | Ramp Width (in) | 42.0 | No | Ramp XSlope (%) | 5.4 |

| | Remove & Replace Curb Ramp With Two New Directional Ramps or Equivalent. | | | |
| | Total Cost: | | \$ | 3200.00 |
