Access Compliance Report

Public Rights-of-Way

(Curb Ramps)

Intersection ID: 20622	Main Street: SANDY_PORTER_RD	Cross Street: TARAGATE_DR	Location: SE
ADA ID: A752E6731DBF	Ramp Type: Directional1	Initial Pass/Fail: Fail	Overall Compliance: No
Severity Score: 21.25			
Codes/Mitigation Info/Possible Solution		Field Measurements/Component Compliance

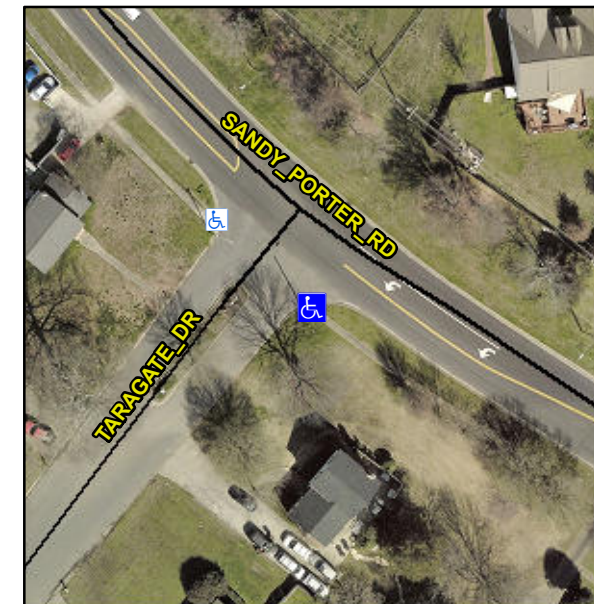
Compliance	Description	Data	Compliance	Description	Data
N/A	Ramp Length (in)	48.0	N/A	Grade Break?	N/A
No	Ramp Width (in)	42.0	N/A	Grade Break Slope (%)	0.0
No	Ramp Slope (%)	8.6	N/A	Grade Break XSlope (%)	0.0
Yes	Ramp XSlope (%)	1.2			
N/A	Flare Type LT	N/A	N/A	Flare Type RT	N/A
N/A	Flare Slope LT (%)	N/A	N/A	Flare Slope RT (%)	0.0
N/A	Flare Traversable LT?	N/A	N/A	Flare Traversable RT?	N/A
N/A	Landing Length (in)	0.0	N/A	DWS Provided?	N/A
N/A	Landing Width (in)	0.0	N/A	DWS Contrast?	N/A
N/A	Landing Slope (%)	0.0	N/A	DWS Length (in)	N/A
N/A	Landing X Slope (%)	0.0	N/A	DWS Full Width?	N/A
N/A	Landing Curb? (Y/N)	N/A	N/A	DWS Offset LT (in)	N/A
N/A	Shared Landing?	N/A	N/A	DWS Offset RT (in)	N/A
N/A	Gutter Ponding?	0.0	N/A	Gutter Slope (%)	N/A
N/A	Gutter Lip Ht (in)	0.0	N/A	Gutter X Slope (%)	N/A
N/A	Painted X Walk1?	No		Road Slope (%)	6.9
	X Walk 1 Direction	To NW		Road X Slope (%)	2.9
	X Walk 1 Width (in)	N/A		Clear Space?	N/A

X Walk 1 Slope (%)	6.9	N/A	Clear Space to XWalk (in)	N/A
	X Walk 1 X Slope (%)	2.9	N/A	Storm Grate/Utility Hazard?	N/A
N/A	Ramp inside XWalk1?	N/A		Storm Grate/Utility Type	
N/A	Any Obstructions?	N/A			N/A
	Obstruction Type		Yes	Surface Condition? (G/P)	Good
			N/A	Curb Slope (%)	12.6

Possible Solutions:

Remove & Replace Entire Ramp.

R304.5.1, R304.2.2
