# Access Compliance Report

## Public Rights-of-Way

### (Curb Ramps)

Intersection ID: 4670	Main Street: CHASEWIND_DR	Cross Street: CONNER_RIDGE_LN	Location: NE
ADA ID: A755E64F18C2	Ramp Type: Perp	Initial Pass/Fail: Fail	Overall Compliance: No
Codes/Mitigation Info/Possible Solution		Field Measurements/Component Compliance

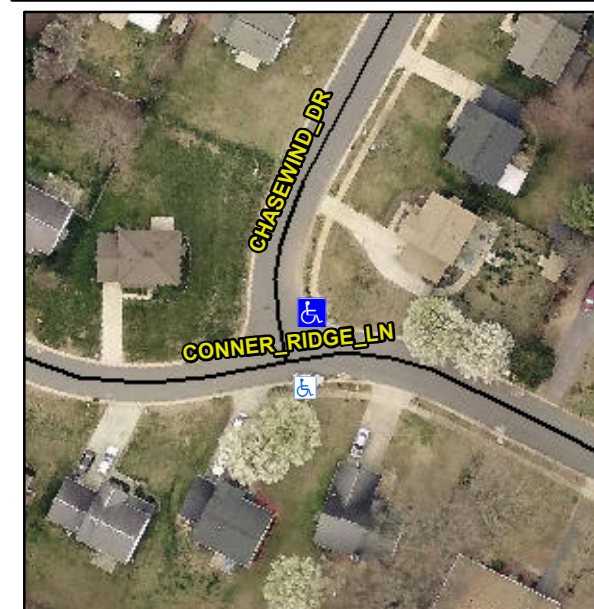
**Not Found, R304.2.2**

Compliance	Description	Data	Compliance	Description	Data
N/A	Ramp Length (in)	48.0	No	Ramp Slope (%)	9.1
Yes	Ramp Width (in)	51.0	Yes	Ramp XSlope (%)	4.5
N/A	Flare Type LT	N/A	N/A	Flare Type RT	N/A
N/A	Flare Slope LT (%)	N/A	N/A	Flare Slope RT (%)	N/A
N/A	Flare Traversable LT?	N/A	N/A	Flare Traversable RT?	N/A
N/A	Landing Length (in)	N/A	N/A	DWS Provided?	N/A
N/A	Landing Width (in)	N/A	N/A	DWS Contrast?	N/A
N/A	Landing Slope (%)	N/A	N/A	DWS Length (in)	N/A
N/A	Landing X Slope (%)	N/A	N/A	DWS Full Width?	N/A
N/A	Landing Curb? (Y/N)	N/A	N/A	DWS Offset (in)	N/A
N/A	Shared Landing?	N/A			
N/A	Gutter Ponding?	N/A	N/A	Gutter Slope (%)	N/A
N/A	Gutter Lip Ht (in)	N/A	N/A	Gutter X Slope (%)	N/A
N/A	Painted X Walk1?	No	N/A	Painted X Walk2?	N/A
	X Walk 1 Direction	To S		X Walk 2 Direction	N/A
N/A	X Walk 1 Width (in)	N/A	N/A	X Walk 2 Width (in)	N/A
	X Walk 1 Slope (%)	3.2		X Walk 2 Slope (%)	N/A
	X Walk 1 X Slope (%)	7.2		X Walk 2 X Slope (%)	N/A

N/A	Ramp inside XWalk1?	N/A	N/A	Ramp inside XWalk2?	N/A
	Road Slope (%)	N/A	N/A	Clear Space?	N/A
	Road X Slope (%)	N/A	N/A	Clear Space to XWalk (in)	N/A
N/A	Any Obstructions?	N/A	N/A	Storm Grate/Utility Hazard?	N/A
	Obstruction Type			Storm Grate/Utility Type	
		N/A			N/A
			Yes	Surface Condition? (G/P)	Good

**Remove & Replace Entire Ramp.**

Total Cost: \$ 1850.00
