Access Compliance Report

Public Rights-of-Way

(Curb Ramps)

Intersection ID: N/A	Main Street: MONROE_RD	Cross Street: MONTROSE_ST	Location: SW
ADA ID: A75BE4F99423	Ramp Type: PerpDiag	Initial Pass/Fail: Fail	Overall Compliance: No
Codes/Mitigation Info/Possible Solution		Field Measurements/Component Compliance

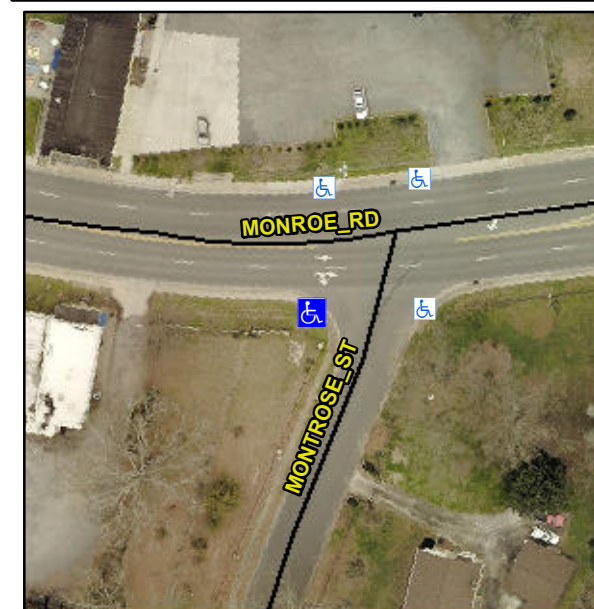
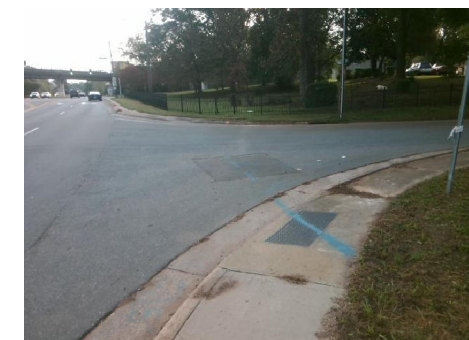
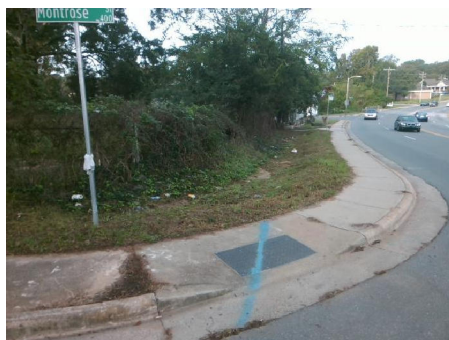
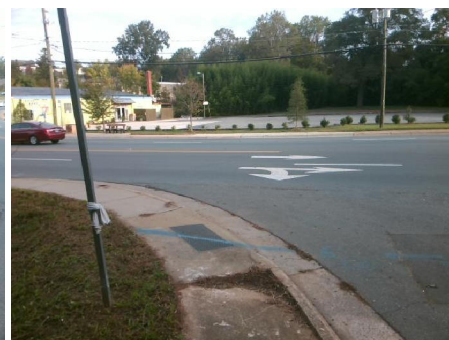
Not Found, R304.2.2, R304.5.3

Compliance	Description	Data	Compliance	Description	Data
N/A	Ramp Length (in)	55.0	No	Ramp Slope (%)	10.6
Yes	Ramp Width (in)	48.0	No	Ramp XSlope (%)	5.1
N/A	Flare Type LT	N/A	N/A	Flare Type RT	N/A
N/A	Flare Slope LT (%)	N/A	N/A	Flare Slope RT (%)	N/A
N/A	Flare Traversable LT?	N/A	N/A	Flare Traversable RT?	N/A
N/A	Landing Length (in)	N/A	N/A	DWS Provided?	N/A
N/A	Landing Width (in)	N/A	N/A	DWS Contrast?	N/A
N/A	Landing Slope (%)	N/A	N/A	DWS Length (in)	N/A
N/A	Landing X Slope (%)	N/A	N/A	DWS Full Width?	N/A
N/A	Landing Curb? (Y/N)	N/A	N/A	DWS Offset (in)	N/A
N/A	Shared Landing?	N/A			
N/A	Gutter Ponding?	N/A	N/A	Gutter Slope (%)	N/A
N/A	Gutter Lip Ht (in)	N/A	N/A	Gutter X Slope (%)	N/A
N/A	Painted X Walk1?	No	N/A	Painted X Walk2?	No
	X Walk 1 Direction	To SE		X Walk 2 Direction	To NE
N/A	X Walk 1 Width (in)	N/A	N/A	X Walk 2 Width (in)	N/A
	X Walk 1 Slope (%)	7.0		X Walk 2 Slope (%)	0.7
	X Walk 1 X Slope (%)	0.9		X Walk 2 X Slope (%)	4.4

N/A	Ramp inside XWalk1?	N/A	N/A	Ramp inside XWalk2?	N/A
	Road Slope (%)	3.9	N/A	Clear Space?	N/A
	Road X Slope (%)	3.6	N/A	Clear Space to XWalk (in)	N/A
N/A	Any Obstructions?	N/A	N/A	Storm Grate/Utility Hazard?	N/A
	Obstruction Type			Storm Grate/Utility Type	
		N/A			N/A
			Yes	Surface Condition? (G/P)	Good

Remove & Replace Curb Ramp With Two New Directional Ramps or Equivalent.
