Access Compliance Report

Public Rights-of-Way

(Curb Ramps)

Intersection ID: 26999	Main Street: SETON_HOUSE_LN	Cross Street: SHEPHERDLEAS_LN	Location: NW
ADA ID: A771DB1D9DE9	Ramp Type: Perp	Initial Pass/Fail: Fail	Overall Compliance: No
Severity Score: 12.5			
Codes/Mitigation Info/Possible Solution		Field Measurements/Component Compliance

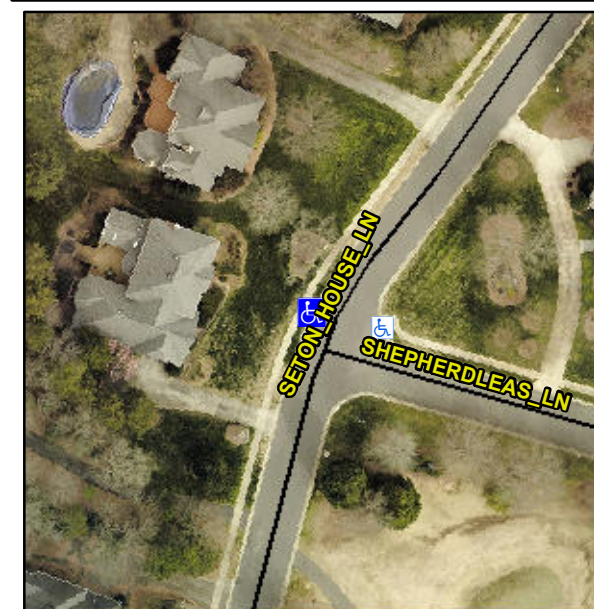
Compliance	Description	Data	Compliance	Description	Data
N/A	Ramp Length (in)	93.0	No	Ramp Slope (%)	10.5
Yes	Ramp Width (in)	50.5	Yes	Ramp XSlope (%)	0.7
N/A	Flare Type LT	N/A	N/A	Flare Type RT	N/A
N/A	Flare Slope LT (%)	N/A	N/A	Flare Slope RT (%)	N/A
N/A	Flare Traversable LT?	N/A	N/A	Flare Traversable RT?	N/A
N/A	Landing Length (in)	N/A	N/A	DWS Provided?	N/A
N/A	Landing Width (in)	N/A	N/A	DWS Contrast?	N/A
N/A	Landing Slope (%)	N/A	N/A	DWS Length (in)	N/A
N/A	Landing X Slope (%)	N/A	N/A	DWS Full Width?	N/A
N/A	Landing Curb? (Y/N)	N/A	N/A	DWS Offset (in)	N/A
N/A	Shared Landing?	N/A			
N/A	Gutter Ponding?	N/A	N/A	Gutter Slope (%)	N/A
N/A	Gutter Lip Ht (in)	N/A	N/A	Gutter X Slope (%)	N/A
N/A	Painted X Walk1?	No	N/A	Painted X Walk2?	N/A
	X Walk 1 Direction	To E		X Walk 2 Direction	N/A
N/A	X Walk 1 Width (in)	N/A	N/A	X Walk 2 Width (in)	N/A
	X Walk 1 Slope (%)	3.4		X Walk 2 Slope (%)	N/A
	X Walk 1 X Slope (%)	2.8		X Walk 2 X Slope (%)	N/A

N/A	Ramp inside XWalk1?	N/A	N/A	Ramp inside XWalk2?	N/A
	Road Slope (%)	N/A	N/A	Clear Space?	N/A
	Road X Slope (%)	N/A	N/A	Clear Space to XWalk (in)	N/A
N/A	Any Obstructions?	N/A	N/A	Storm Grate/Utility Hazard?	N/A
	Obstruction Type			Storm Grate/Utility Type	
		N/A			N/A
			Yes	Surface Condition? (G/P)	Good

Possible Solutions:

Remove & Replace Entire Ramp.

PROW/ADA:

R304.2.2
