Access Compliance Report

Public Rights-of-Way

(Curb Ramps)

Intersection ID: 29157	Main Street: STONEY_GARDEN_DR	Cross Street: WALLACE_RIDGE_DR	Location: SW
ADA ID: A78657C9DD02	Ramp Type: BlendTrans1	Initial Pass/Fail: Fail	Overall Compliance: No
Severity Score: 8.75			
Codes/Mitigation Info/Possible Solution		Field Measurements/Component Compliance

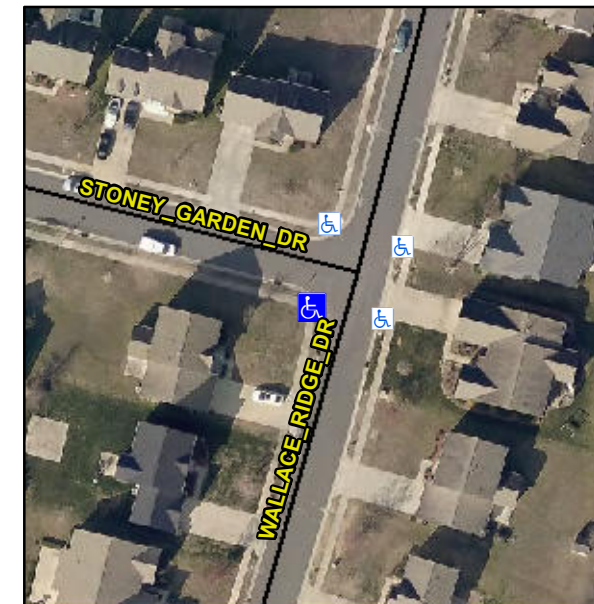
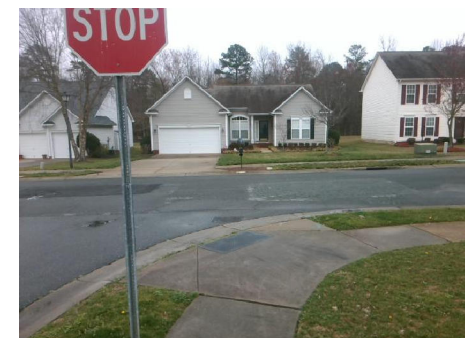
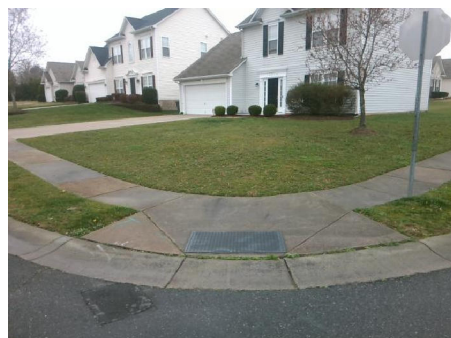
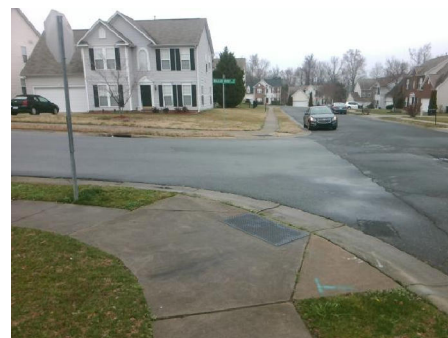
Compliance	Description	Data	Compliance	Description	Data
N/A	Ramp Length (in)	48.0	Yes	BlendTrans Slope (%)	4.3
No	Ramp Width (in)	44.0	Yes	BlendTrans XSlope (%)	1.6
N/A	Flare Type LT	N/A	N/A	Flare Type RT	N/A
N/A	Flare Slope LT (%)	N/A	N/A	Flare Slope RT (%)	N/A
N/A	Flare Traversable LT?	N/A	N/A	Flare Traversable RT?	N/A
N/A	Landing Length (in)	N/A	N/A	DWS Provided?	N/A
N/A	Landing Width (in)	N/A	N/A	DWS Contrast?	N/A
N/A	Landing Slope (%)	N/A	N/A	DWS Length (in)	N/A
N/A	Landing X Slope (%)	N/A	N/A	DWS Full Width?	N/A
N/A	Landing Curb? (Y/N)	N/A	N/A	DWS Offset (in)	N/A
N/A	Shared Landing?	N/A			
N/A	Gutter Ponding?	N/A	N/A	Gutter Slope (%)	N/A
N/A	Gutter Lip Ht (in)	N/A	N/A	Gutter X Slope (%)	N/A
N/A	Painted X Walk1?	No	N/A	Painted X Walk2?	No
	X Walk 1 Direction	To E		X Walk 2 Direction	To N
	X Walk 1 Width (in)	N/A		X Walk 2 Width (in)	N/A
	X Walk 1 Slope (%)	1.3		X Walk 2 Slope (%)	0.1
	X Walk 1 X Slope (%)	0.3		X Walk 2 X Slope (%)	3.7

N/A	Ramp inside XWalk1?	N/A	N/A	Ramp inside XWalk2?	N/A
	Road Slope (%)	1.1		Clear Space?	N/A
	Road X Slope (%)	0.3	N/A	Clear Space to XWalk (in)	N/A
N/A	Any Obstructions?	N/A	N/A	Storm Grate/Utility Hazard?	N/A
	Obstruction Type			Storm Grate/Utility Type	
		N/A			N/A
			Yes	Surface Condition? (G/P)	Good
			N/A	Curb Slope (%)	4.3

Possible Solutions:

Remove & Replace Curb Ramp With Two New Directional Ramps or Equivalent.

R304.5.1
