Access Compliance Report

Public Rights-of-Way

(Curb Ramps)

Intersection ID: 8364	Main Street: ENGLISH_DR	Cross Street: LASALLE_ST	Location: NE
ADA ID: A78ACE4F42C5	Ramp Type: Perp	Initial Pass/Fail: Fail	Overall Compliance: No
Codes/Mitigation Info/Possible Solution			Severity Score: 10
			Field Measurements/Component Compliance

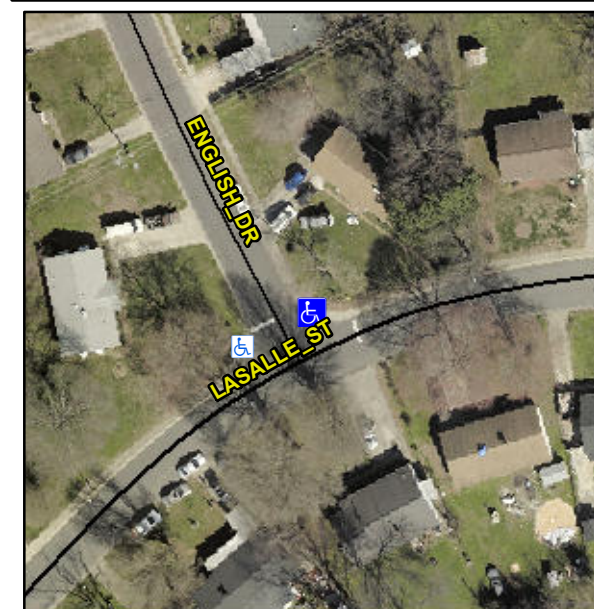
Not Found, R304.5.1, R304.5.3

Compliance	Description	Data	Compliance	Description	Data
N/A	Ramp Length (in)	58.0	Yes	Ramp Slope (%)	6.3
No	Ramp Width (in)	47.5	No	Ramp XSlope (%)	3.9
N/A	Flare Type LT	N/A	N/A	Flare Type RT	N/A
N/A	Flare Slope LT (%)	N/A	N/A	Flare Slope RT (%)	N/A
N/A	Flare Traversable LT?	N/A	N/A	Flare Traversable RT?	N/A
N/A	Landing Length (in)	N/A	N/A	DWS Provided?	N/A
N/A	Landing Width (in)	N/A	N/A	DWS Contrast?	N/A
N/A	Landing Slope (%)	N/A	N/A	DWS Length (in)	N/A
N/A	Landing X Slope (%)	N/A	N/A	DWS Full Width?	N/A
N/A	Landing Curb? (Y/N)	N/A	N/A	DWS Offset (in)	N/A
N/A	Shared Landing?	N/A			
N/A	Gutter Ponding?	N/A	N/A	Gutter Slope (%)	N/A
N/A	Gutter Lip Ht (in)	N/A	N/A	Gutter X Slope (%)	N/A
N/A	Painted X Walk1?	No	N/A	Painted X Walk2?	N/A
	X Walk 1 Direction	To SW		X Walk 2 Direction	N/A
N/A	X Walk 1 Width (in)	N/A	N/A	X Walk 2 Width (in)	N/A
	X Walk 1 Slope (%)	0.5		X Walk 2 Slope (%)	N/A
	X Walk 1 X Slope (%)	1.8		X Walk 2 X Slope (%)	N/A

N/A	Ramp inside XWalk1?	N/A	N/A	Ramp inside XWalk2?	N/A
	Road Slope (%)	N/A	N/A	Clear Space?	N/A
	Road X Slope (%)	N/A	N/A	Clear Space to XWalk (in)	N/A
N/A	Any Obstructions?	N/A	N/A	Storm Grate/Utility Hazard?	N/A
	Obstruction Type			Storm Grate/Utility Type	
		N/A			N/A
			Yes	Surface Condition? (G/P)	Good

Possible Solutions:

Remove & Replace Entire Ramp.

Total Cost: \$ 1850.00
