## Access Compliance Report Public Rights-of-Way (Curb Ramps)

Intersection ID: 12896 Main Street: E\_6TH\_ST Cross Street: N\_MCDOWELL\_ST Location: E

ADA ID: A78BD1232522 Ramp Type: Perp Initial Pass/Fail: Pass Overall Compliance: No Severity Score: 10.25

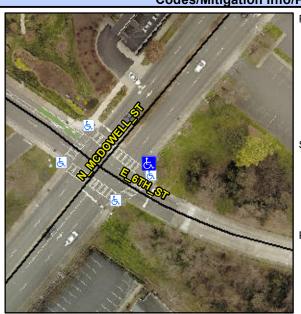
PROW/ADA:
Not Found, R304.5.3, R304.2.1,
R304.2.2-Perp, R304.3.2-Para,
R305.2, R207.1

Field Measurements/Component Compliance					
Compliance Description		Data	Comp	liance Description	Data
N/A	Ramp Length (in)	72.0	Yes	Ramp Slope (%)	8.3
Yes	Ramp Width (in)	54.0	No	Ramp XSlope (%)	2.9
N/A	Flare Type LT	Sloped	N/A	Flare Type RT	N/A
N/A	Flare Slope LT (%)	7.0	Yes	Flare Slope RT (%)	9.3
N/A	Flare Traversable LT?	Yes	N/A	Flare Traversable RT?	Yes
No	Landing Length (in)	N/A	Yes	DWS Provided?	Yes
No	Landing Width (in)	N/A	Yes	DWS Contrast?	Yes
No	Landing Slope (%)	N/A	Yes	DWS Length (in)	24.0
No	Landing X Slope (%)	N/A	Yes	DWS Full Width?	Yes
N/A	Landing Curb? (Y/N)	No	No	DWS Offset (in)	4.0
N/A	Shared Landing?	No			
Yes	Gutter Ponding?	No	Yes	Gutter Slope (%)	4.4
Yes	Gutter Lip Ht (in)	0.0	Yes	Gutter X Slope (%)	1.0
N/A	Painted X Walk1?	Yes	N/A	Painted X Walk2?	N/A
	X Walk 1 Direction	To NW		X Walk 2 Direction	N/A
N/A	X Walk 1 Width (in)	113.0	N/A	X Walk 2 Width (in)	N/A
	X Walk 1 Slope (%)	1.8		X Walk 2 Slope (%)	N/A

X Walk 1 X Slope (%)	1.1		X Walk 2 X Slope (%)	N/A
No	Ramp inside XWalk1?	No	N/A	Ramp inside XWalk2?	N/A
	Road Slope (%)	N/A	N/A	Clear Space?	Yes
	Road X Slope (%)	N/A	N/A	Clear Space to XWalk (in)	N/A
Yes	Any Obstructions?	No	Yes	Storm Grate/Utility Hazard?	No
	Obstruction Type			Storm Grate/Utility Type	
		N/A			N/A
			Yes	Surface Condition? (G/P)	Good

Remove & Replace Entire Ramp.
Restripe Crosswalk.
