# Access Compliance Report

## Public Rights-of-Way

### (Curb Ramps)

| Intersection ID: 45488 | Main Street: CAPTAIN_ARDREY_RD | Cross Street: GINHOUSE_LN | Location: NE |

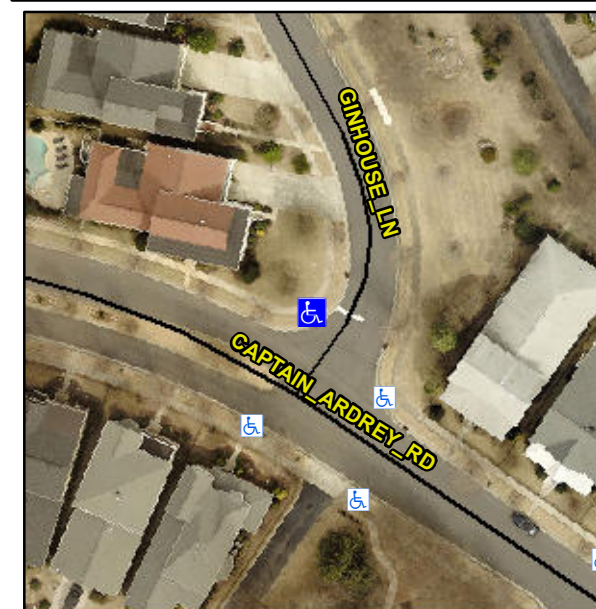
**Not Found, R304.5.1, R304.2.2**

| Compliance | Description | Data | Compliance | Description | Data |
|---|---|---|---|---|---|
| N/A | Ramp Length (in) | 74.0 | No | Ramp Slope (%) | 13.0 |
| No | Ramp Width (in) | 36.0 | Yes | Ramp XSlope (%) | 1.4 |

**Remove & Replace Curb Ramp With Two New Directional Ramps or Equivalent.**

Total Cost: \$ 3200.00
