Access Compliance Report Public Rights-of-Way (Curb Ramps)

Intersection ID: 52336 Main Street: WOODWARD_AV Cross Street: KOHLER_AV Location: E

ADA ID: A7B21EB323A6 Ramp Type: Perp Initial Pass/Fail: Pass Overall Compliance: No Severity Score: 7.5

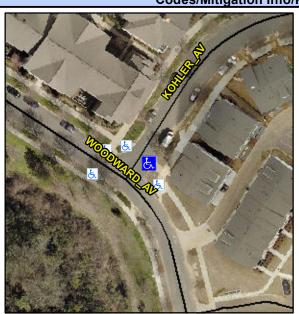
Not Found, R304.2.2-Perp, R304.3.2-Para, R305.1.4, R305.2, R302.7, R302.7.2

Compliance Description		Data	Compliance Description		Data
N/A	Ramp Length (in)	152.5	Yes	Ramp Slope (%)	5.9
Yes	Ramp Width (in)	95.5	Yes	Ramp XSlope (%)	0.6
N/A	Flare Type LT	Sloped	N/A	Flare Type RT	N/A
N/A	Flare Slope LT (%)	6.4	N/A	Flare Slope RT (%)	8.9
N/A	Flare Traversable LT?	No	N/A	Flare Traversable RT?	No
Yes	Landing Length (in)	92.5	Yes	DWS Provided?	Yes
Yes	Landing Width (in)	95.5	Yes	DWS Contrast?	Yes
No	Landing Slope (%)	3.2	No	DWS Length (in)	23.5
Yes	Landing X Slope (%)	0.5	Yes	DWS Full Width?	Yes
N/A	Landing Curb? (Y/N)	No	No	DWS Offset (in)	4.0
N/A	Shared Landing?	No			
No	Gutter Ponding?	Yes	Yes	Gutter Slope (%)	3.5
No	Gutter Lip Ht (in)	0.5	Yes	Gutter X Slope (%)	1.0
N/A	Painted X Walk1?	No	N/A	Painted X Walk2?	N/A
	X Walk 1 Direction	To NW		X Walk 2 Direction	N/A
N/A	X Walk 1 Width (in)	N/A	N/A	X Walk 2 Width (in)	N/A
	X Walk 1 Slope (%)	3.8		X Walk 2 Slope (%)	N/A
	X Walk 1 X Slope (%)	1.4		X Walk 2 X Slope (%)	N/A

N/A	Ramp inside XWalk1?	N/A	N/A	Ramp inside XWalk2?	N/A
	Road Slope (%)	N/A	N/A	Clear Space?	Yes
	Road X Slope (%)	N/A	N/A	Clear Space to XWalk (in)	N/A
Yes	Any Obstructions?	No	Yes	Storm Grate/Utility Hazard?	No
	Obstruction Type			Storm Grate/Utility Type	
		N/A			N/A

Remove & Replace Entire Ramp.
