## Access Compliance Report Public Rights-of-Way (Curb Ramps)

Intersection ID: 18029Main Street:E\_WOODLAWN\_RDCross Street:OLD\_WOODS\_RDLocation:SWADA ID: A7C5FC464587Ramp Type:Directional2Initial Pass/Fail:FailOverall Compliance:NoSeverity Score:25

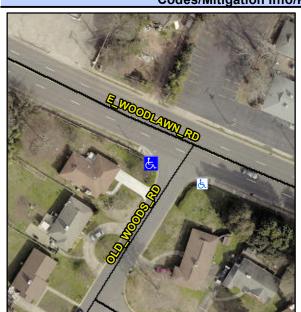
Compliance Description Data Compliance Description					
N/A			N/A	Grade Break?	Data N/A
Yes	Ramp Length (in)	77.0 57.0	N/A N/A		0.0
	Ramp Width (in)			Grade Break Slope (%)	
No	Ramp Slope (%)	12.5	N/A	Grade Break XSlope (%)	0.0
Yes	Ramp XSlope (%)	0.5			
N/A	Flare Type LT	N/A	N/A	Flare Type RT	N/A
N/A	Flare Slope LT (%)	N/A	N/A	Flare Slope RT (%)	0.0
N/A	Flare Traversable LT?	N/A	N/A	Flare Traversable RT?	N/A
N/A	Landing Length (in)	0.0	N/A	DWS Provided?	N/A
N/A	Landing Width (in)	0.0	N/A	DWS Contrast?	N/A
N/A	Landing Slope (%)	0.0	N/A	DWS Length (in)	N/A
N/A	Landing X Slope (%)	0.0	N/A	DWS Full Width?	N/A
N/A	Landing Curb? (Y/N)	N/A	N/A	DWS Offset LT (in)	N/A
N/A	Shared Landing?	N/A	N/A	DWS Offset RT (in)	N/A
N/A	Gutter Ponding?	0.0	N/A	Gutter Slope (%)	N/A
N/A	Gutter Lip Ht (in)	0.0	N/A	Gutter X Slope (%)	N/A
N/A	Painted X Walk1?	No		Road Slope (%)	1.0
	X Walk 1 Direction	To E		Road X Slope (%)	3.0
	X Walk 1 Width (in)	N/A		Clear Space?	N/A

X Walk 1 Slope (%)	1.0	N/A	Clear Space to XWalk (in)	N/A
	X Walk 1 X Slope (%)	3.0	N/A	Storm Grate/Utility Hazard?	N/A
N/A	Ramp inside XWalk1?	N/A		Storm Grate/Utility Type	
N/A	Any Obstructions?	N/A			N/A
	Obstruction Type		Yes	Surface Condition? (G/P)	Good
		N/A	N/A	Curb Slope (%)	1.4

Remove & Replace Entire Ramp.

R304.2.2
