Access Compliance Report

Public Rights-of-Way

(Curb Ramps)

Intersection ID: 24374	Main Street: BEVERLY_CREST_BV	Cross Street: PINEVILLE-MATTHEWS_RD	Location: NW
ADA ID: A7C82201686D	Ramp Type: Perp	Initial Pass/Fail: Fail	Overall Compliance: No
		Severity Score: 37.5

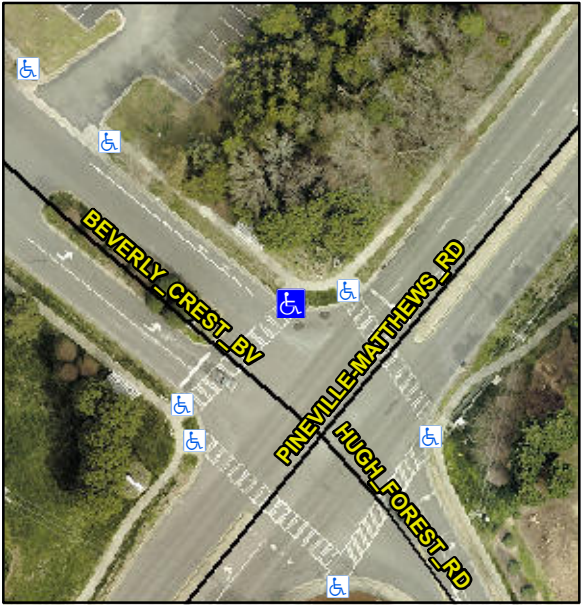
Possible Solutions:		Compliance	Description	Data
	Remove & Replace Entire Ramp.		No	Ramp Length (in)	101.0
			Yes	Ramp Width (in)	60.0
			N/A	Flare Type LT	N/A
			N/A	Flare Slope LT (%)	N/A
			N/A	Flare Traversable LT?	N/A
			N/A	Landing Length (in)	N/A
			N/A	Landing Width (in)	N/A
			N/A	Landing Slope (%)	N/A
			N/A	Landing X Slope (%)	N/A
<p>Surveyor Notes:</p> <p>N/A</p> <p>PROW/ADA:</p> <p>Not Found, R304.2.2, R304.5.3</p>			N/A	Flare Type RT	N/A
			N/A	Flare Slope RT (%)	N/A
			N/A	Flare Traversable RT?	N/A
			N/A	DWS Provided?	N/A
			N/A	DWS Contrast?	N/A
			N/A	DWS Length (in)	N/A
			N/A	DWS Full Width?	N/A
			N/A	DWS Offset (in)	N/A
			N/A	Gutter Ponding?	N/A
			N/A	Gutter Lip Ht (in)	N/A
<p>Total Cost:</p> <p>\$ 1850.00</p>			Yes	Painted X Walk1?	N/A
			N/A	X Walk 1 Direction	To SW
			N/A	X Walk 1 Width (in)	117.0
			N/A	X Walk 1 Slope (%)	3.3

N/A	X Walk 1 X Slope (%)	6.8
			N/A	Ramp inside XWalk1?	Yes
			N/A	Road Slope (%)	N/A
			N/A	Road X Slope (%)	N/A
			N/A	Any Obstructions?	N/A
			N/A	Obstruction Type	N/A
			N/A	Clear Space?	N/A
			N/A	Clear Space to XWalk (in)	N/A
			N/A	Storm Grate/Utility Hazard?	N/A
			N/A	Storm Grate/Utility Type	N/A
			Yes	Surface Condition? (G/P)	Good
