# Access Compliance Report

## Public Rights-of-Way

### (Curb Ramps)

| Intersection ID: 2741 | Main Street: CHRISTENBURY_RD | Cross Street: MILLSTREAM_RIDGE_DR | Location: SW |

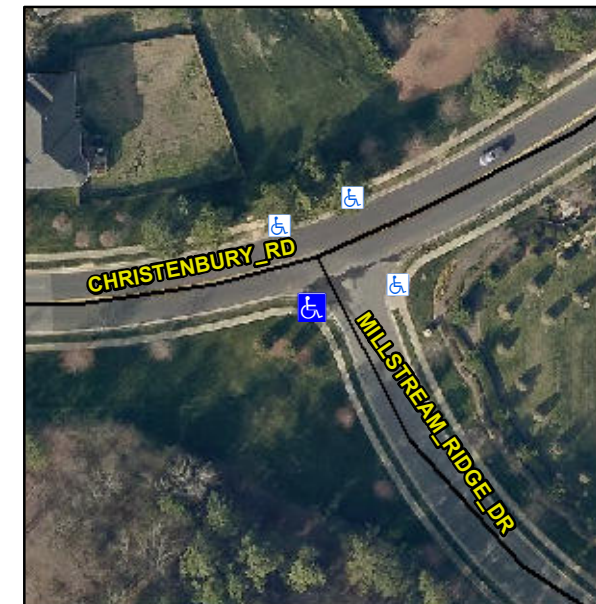
| ADA ID: A7CC677F589E | Ramp Type: BlendTrans1 | Initial Pass/Fail: Fail | Overall Compliance: No |
| Codes/Mitigation Info/Possible Solution | | | Severity Score: 10 |

**R304.5.1, R304.5.3**

| Compliance | Description | Data | Compliance | Description | Data |
|---|---|---|---|---|---|
| No | Ramp Width (in) | 39.5 | No | BlendTrans XSlope (%) | 2.8 |

**Remove & Replace Curb Ramp With Two New Directional Ramps or Equivalent.**

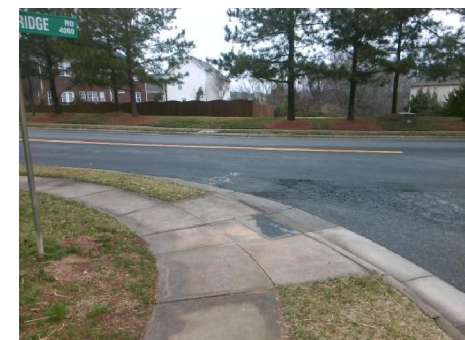
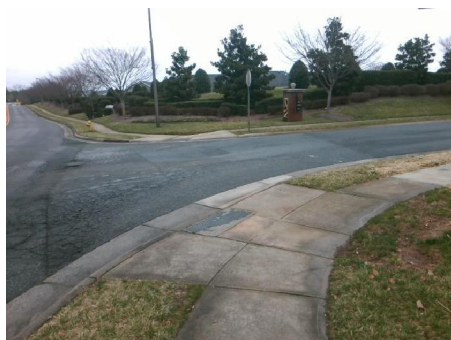
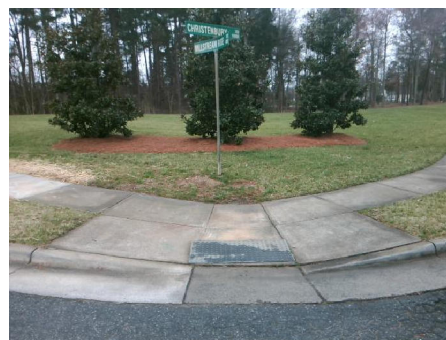
| Compliance | Description | Data | Compliance | Description | Data |
|---|---|---|---|---|---|
| N/A | Ramp Length (in) | 45.0 | Yes | BlendTrans Slope (%) | 4.7 |
| N/A | Gutter Lip Ht (in) | 1.5 | N/A | Gutter X Slope (%) | N/A |
