Access Compliance Report

Public Rights-of-Way

(Curb Ramps)

Intersection ID: 32311	Main Street: LAUREL_WALK_CT	Cross Street: NEW_PROVIDENCE_LN	Location: NE
ADA ID: A7D0022AC863	Ramp Type: BlendTrans1	Initial Pass/Fail: Fail	Overall Compliance: No
		Severity Score: 10

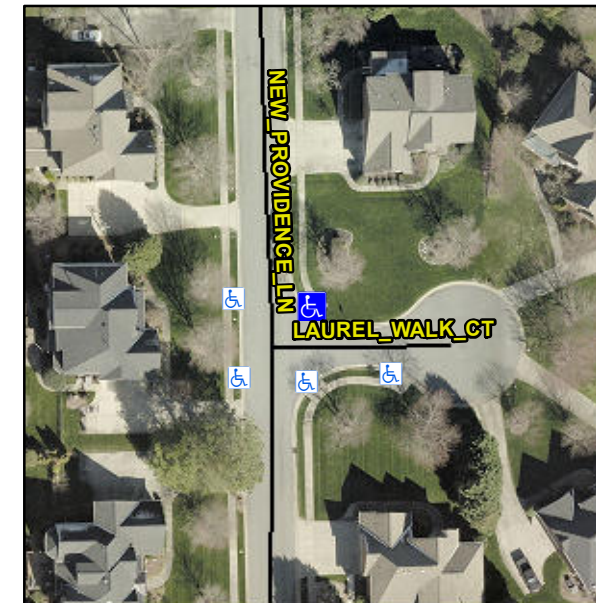
Not Found, R304.5.1, R304.5.3

Compliance	Description	Data	Compliance	Description	Data
N/A	Ramp Length (in)	48.0	Yes	BlendTrans Slope (%)	4.7
No	Ramp Width (in)	36.5	No	BlendTrans XSlope (%)	3.3
N/A	Flare Type LT	N/A	N/A	Flare Type RT	N/A
N/A	Flare Slope LT (%)	N/A	N/A	Flare Slope RT (%)	N/A
N/A	Flare Traversable LT?	N/A	N/A	Flare Traversable RT?	N/A
N/A	Landing Length (in)	N/A	N/A	DWS Provided?	N/A
N/A	Landing Width (in)	N/A	N/A	DWS Contrast?	N/A
N/A	Landing Slope (%)	N/A	N/A	DWS Length (in)	N/A
N/A	Landing X Slope (%)	N/A	N/A	DWS Full Width?	N/A
N/A	Landing Curb? (Y/N)	N/A	N/A	DWS Offset (in)	N/A
N/A	Shared Landing?	N/A			
N/A	Gutter Ponding?	N/A	N/A	Gutter Slope (%)	N/A
N/A	Gutter Lip Ht (in)	N/A	N/A	Gutter X Slope (%)	N/A
N/A	Painted X Walk1?	No	N/A	Painted X Walk2?	No
	X Walk 1 Direction	To W		X Walk 2 Direction	To S
	X Walk 1 Width (in)	N/A		X Walk 2 Width (in)	N/A
	X Walk 1 Slope (%)	2.2		X Walk 2 Slope (%)	6.7
	X Walk 1 X Slope (%)	6.1		X Walk 2 X Slope (%)	0.2

N/A	Ramp inside XWalk1?	N/A	N/A	Ramp inside XWalk2?	N/A
	Road Slope (%)	3.1		Clear Space?	N/A
	Road X Slope (%)	5.7	N/A	Clear Space to XWalk (in)	N/A
N/A	Any Obstructions?	N/A	N/A	Storm Grate/Utility Hazard?	N/A
	Obstruction Type			Storm Grate/Utility Type	
		N/A			N/A
			Yes	Surface Condition? (G/P)	Good
			No	Curb Slope (%)	6.3

Possible Solutions:

Remove & Replace Curb Ramp With Two New Directional Ramps or Equivalent.
