Access Compliance Report

Public Rights-of-Way

(Curb Ramps)

Intersection ID: 12489	Main Street: CHESTNUT_AV	Cross Street: NASSAU_BV	Location: SE
ADA ID: A7D720221FD6	Ramp Type: BlendTrans1	Initial Pass/Fail: Fail	Overall Compliance: No
		Severity Score: 10

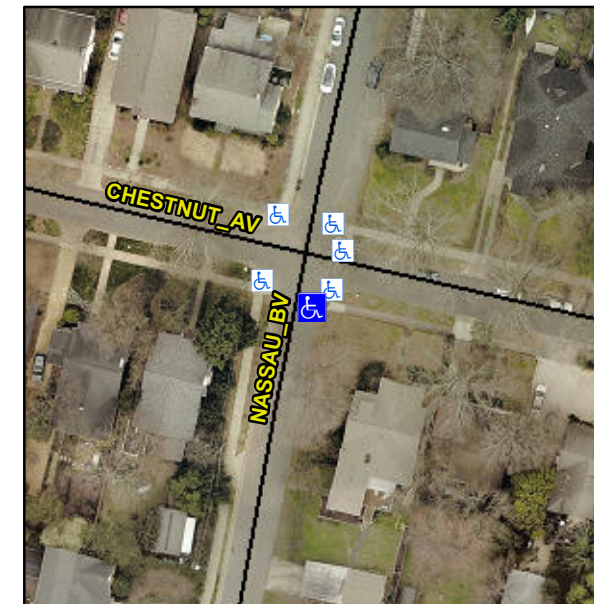
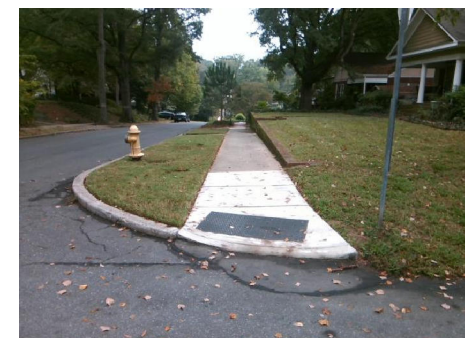
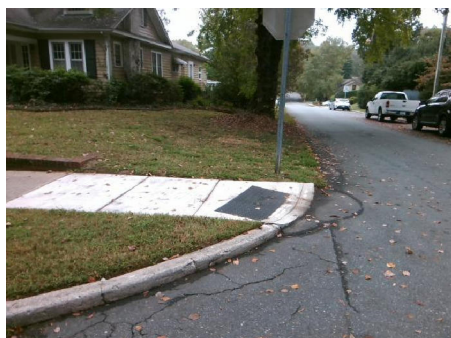
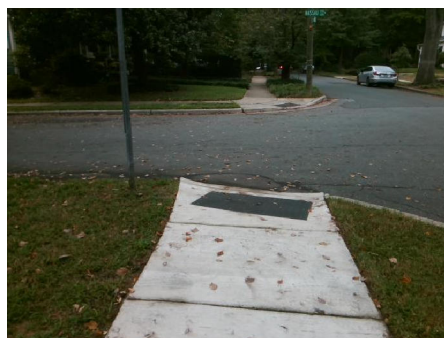
Not Found, R304.5.1, R304.5.3

Compliance	Description	Data	Compliance	Description	Data
N/A	Ramp Length (in)	33.0	Yes	BlendTrans Slope (%)	4.7
No	Ramp Width (in)	36.0	No	BlendTrans XSlope (%)	3.5
N/A	Flare Type LT	N/A	N/A	Flare Type RT	N/A
N/A	Flare Slope LT (%)	N/A	N/A	Flare Slope RT (%)	N/A
N/A	Flare Traversable LT?	N/A	N/A	Flare Traversable RT?	N/A
N/A	Landing Length (in)	N/A	N/A	DWS Provided?	N/A
N/A	Landing Width (in)	N/A	N/A	DWS Contrast?	N/A
N/A	Landing Slope (%)	N/A	N/A	DWS Length (in)	N/A
N/A	Landing X Slope (%)	N/A	N/A	DWS Full Width?	N/A
N/A	Landing Curb? (Y/N)	N/A	N/A	DWS Offset (in)	N/A
N/A	Shared Landing?	N/A			
N/A	Gutter Ponding?	N/A	N/A	Gutter Slope (%)	N/A
N/A	Gutter Lip Ht (in)	0.5	N/A	Gutter X Slope (%)	N/A
N/A	Painted X Walk1?	No	N/A	Painted X Walk2?	N/A
	X Walk 1 Direction	To W		X Walk 2 Direction	N/A
	X Walk 1 Width (in)	N/A		X Walk 2 Width (in)	N/A
	X Walk 1 Slope (%)	3.3		X Walk 2 Slope (%)	N/A
	X Walk 1 X Slope (%)	3.5		X Walk 2 X Slope (%)	N/A

N/A	Ramp inside XWalk1?	N/A	N/A	Ramp inside XWalk2?	N/A
	Road Slope (%)	3.5		Clear Space?	N/A
	Road X Slope (%)	3.3	N/A	Clear Space to XWalk (in)	N/A
N/A	Any Obstructions?	N/A	N/A	Storm Grate/Utility Hazard?	N/A
	Obstruction Type			Storm Grate/Utility Type	
		N/A			N/A
			Yes	Surface Condition? (G/P)	Good
			No	Curb Slope (%)	5.3

Remove & Replace Curb Ramp With Two New Directional Ramps or Equivalent.
