Access Compliance Report

Public Rights-of-Way

(Curb Ramps)

Intersection ID: 24428	Main Street: PRESCOTT_POND_LN	Cross Street: SAINTFIELD_PL	Location: NE
ADA ID: A7D7D40E9C72	Ramp Type: PerpDiag	Initial Pass/Fail: Fail	Overall Compliance: No
Codes/Mitigation Info/Possible Solution			Severity Score: 10
Field Measurements/Component Compliance

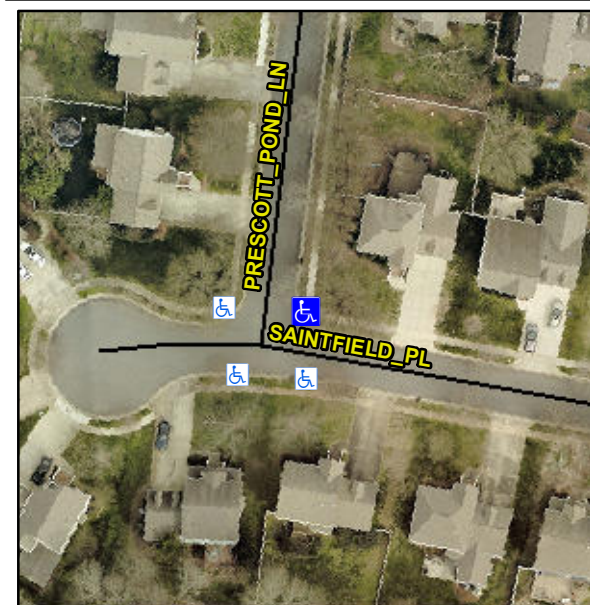
Not Found, R304.5.1, R304.5.3

Compliance	Description	Data	Compliance	Description	Data
N/A	Ramp Length (in)	48.0	Yes	Ramp Slope (%)	5.1
No	Ramp Width (in)	46.5	No	Ramp XSlope (%)	3.2
N/A	Flare Type LT	N/A	N/A	Flare Type RT	N/A
N/A	Flare Slope LT (%)	N/A	N/A	Flare Slope RT (%)	N/A
N/A	Flare Traversable LT?	N/A	N/A	Flare Traversable RT?	N/A
N/A	Landing Length (in)	N/A	N/A	DWS Provided?	N/A
N/A	Landing Width (in)	N/A	N/A	DWS Contrast?	N/A
N/A	Landing Slope (%)	N/A	N/A	DWS Length (in)	N/A
N/A	Landing X Slope (%)	N/A	N/A	DWS Full Width?	N/A
N/A	Landing Curb? (Y/N)	N/A	N/A	DWS Offset (in)	N/A
N/A	Shared Landing?	N/A			
N/A	Gutter Ponding?	N/A	N/A	Gutter Slope (%)	N/A
N/A	Gutter Lip Ht (in)	N/A	N/A	Gutter X Slope (%)	N/A
N/A	Painted X Walk1?	No	N/A	Painted X Walk2?	No
	X Walk 1 Direction	To SW		X Walk 2 Direction	To S
N/A	X Walk 1 Width (in)	N/A	N/A	X Walk 2 Width (in)	N/A
	X Walk 1 Slope (%)	1.1		X Walk 2 Slope (%)	3.7
	X Walk 1 X Slope (%)	1.4		X Walk 2 X Slope (%)	0.0

N/A	Ramp inside XWalk1?	N/A	N/A	Ramp inside XWalk2?	N/A
	Road Slope (%)	2.0	N/A	Clear Space?	N/A
	Road X Slope (%)	5.2	N/A	Clear Space to XWalk (in)	N/A
N/A	Any Obstructions?	N/A	N/A	Storm Grate/Utility Hazard?	N/A
	Obstruction Type			Storm Grate/Utility Type	
		N/A			N/A
			Yes	Surface Condition? (G/P)	Good

Possible Solutions:

Remove & Replace Curb Ramp With Two New Directional Ramps or Equivalent.
