Access Compliance Report

Public Rights-of-Way

(Curb Ramps)

Intersection ID: 11660	Main Street: E_20TH_ST	Cross Street: HARRILL_ST	Location: W
ADA ID: A7DA33B72344	Ramp Type: BlendTrans1	Initial Pass/Fail: Fail	Overall Compliance: No
Severity Score: 17.5			
Codes/Mitigation Info/Possible Solution		Field Measurements/Component Compliance

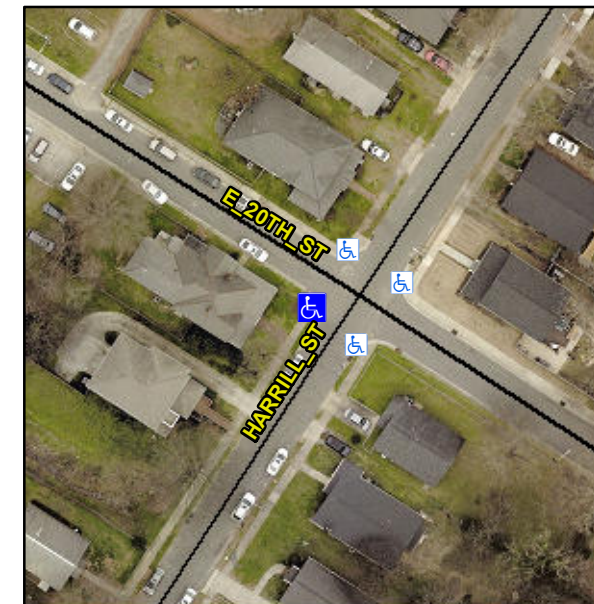
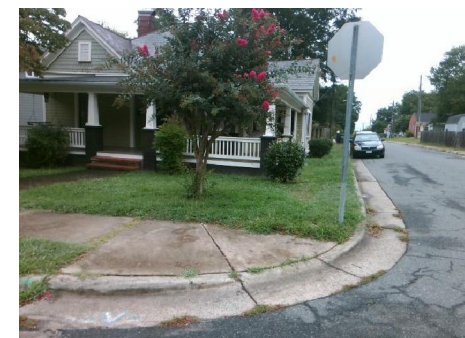
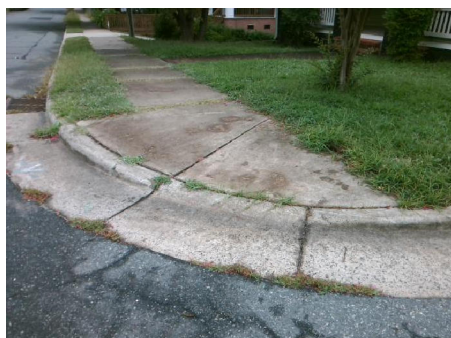
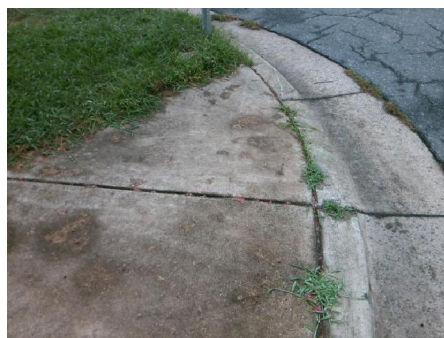
RP < 5%

Not Found, R304.5.1

Compliance	Description	Data	Compliance	Description	Data
N/A	Ramp Length (in)	40.0	Yes	BlendTrans Slope (%)	3.4
No	Ramp Width (in)	35.0	Yes	BlendTrans XSlope (%)	1.2
N/A	Flare Type LT	N/A	N/A	Flare Type RT	N/A
N/A	Flare Slope LT (%)	N/A	N/A	Flare Slope RT (%)	N/A
N/A	Flare Traversable LT?	N/A	N/A	Flare Traversable RT?	N/A
N/A	Landing Length (in)	N/A	N/A	DWS Provided?	N/A
N/A	Landing Width (in)	N/A	N/A	DWS Contrast?	N/A
N/A	Landing Slope (%)	N/A	N/A	DWS Length (in)	N/A
N/A	Landing X Slope (%)	N/A	N/A	DWS Full Width?	N/A
N/A	Landing Curb? (Y/N)	N/A	N/A	DWS Offset (in)	N/A
N/A	Shared Landing?	N/A			
N/A	Gutter Ponding?	N/A	N/A	Gutter Slope (%)	N/A
N/A	Gutter Lip Ht (in)	1.0	N/A	Gutter X Slope (%)	N/A
N/A	Painted X Walk1?	No	N/A	Painted X Walk2?	No
	X Walk 1 Direction	To SE		X Walk 2 Direction	To NE
	X Walk 1 Width (in)	N/A		X Walk 2 Width (in)	N/A
	X Walk 1 Slope (%)	2.6		X Walk 2 Slope (%)	5.6
	X Walk 1 X Slope (%)	3.9		X Walk 2 X Slope (%)	0.7

N/A	Ramp inside XWalk1?	N/A	N/A	Ramp inside XWalk2?	N/A
	Road Slope (%)	6.2		Clear Space?	N/A
	Road X Slope (%)	1.7	N/A	Clear Space to XWalk (in)	N/A
N/A	Any Obstructions?	N/A	N/A	Storm Grate/Utility Hazard?	N/A
	Obstruction Type			Storm Grate/Utility Type	
		N/A			N/A
			Yes	Surface Condition? (G/P)	Good
			No	Curb Slope (%)	21.9

Possible Solutions:

Remove & Replace Curb Ramp With Two New Directional Ramps or Equivalent.
