Access Compliance Report

Public Rights-of-Way

(Curb Ramps)

Intersection ID: 12054	Main Street: MCNINCH_ST	Cross Street: W_HILL_ST	Location: SE
ADA ID: A7E8D62C5AF9	Ramp Type: Perp	Initial Pass/Fail: Pass	Overall Compliance: No
Severity Score: 0			
Codes/Mitigation Info/Possible Solution		Field Measurements/Component Compliance

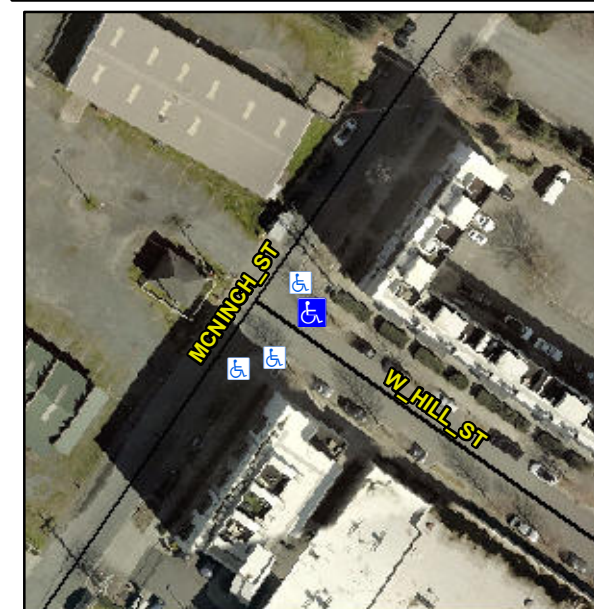
Compliance	Description	Data	Compliance	Description	Data
N/A	Ramp Length (in)	75.0	Yes	Ramp Slope (%)	7.8
Yes	Ramp Width (in)	49.0	Yes	Ramp XSlope (%)	0.6
N/A	Flare Type LT	Sloped	N/A	Flare Type RT	N/A
N/A	Flare Slope LT (%)	6.0	Yes	Flare Slope RT (%)	5.5
N/A	Flare Traversable LT?	Yes	N/A	Flare Traversable RT?	Yes
Yes	Landing Length (in)	72.0	Yes	DWS Provided?	Yes
Yes	Landing Width (in)	49.0	Yes	DWS Contrast?	Yes
Yes	Landing Slope (%)	1.4	Yes	DWS Length (in)	24.0
Yes	Landing X Slope (%)	0.2	Yes	DWS Full Width?	Yes
N/A	Landing Curb? (Y/N)	No	No	DWS Offset (in)	2.5
N/A	Shared Landing?	No			
Yes	Gutter Ponding?	No	Yes	Gutter Slope (%)	2.5
Yes	Gutter Lip Ht (in)	0.0	Yes	Gutter X Slope (%)	0.5
N/A	Painted X Walk1?	No	N/A	Painted X Walk2?	N/A
	X Walk 1 Direction	To SW		X Walk 2 Direction	N/A
N/A	X Walk 1 Width (in)	N/A	N/A	X Walk 2 Width (in)	N/A
	X Walk 1 Slope (%)	2.9		X Walk 2 Slope (%)	N/A
	X Walk 1 X Slope (%)	0.3		X Walk 2 X Slope (%)	N/A

N/A	Ramp inside XWalk1?	N/A	N/A	Ramp inside XWalk2?	N/A
	Road Slope (%)	N/A	N/A	Clear Space?	Yes
	Road X Slope (%)	N/A	N/A	Clear Space to XWalk (in)	N/A
Yes	Any Obstructions?	No	Yes	Storm Grate/Utility Hazard?	No
	Obstruction Type			Storm Grate/Utility Type	
		N/A			N/A
			Yes	Surface Condition? (G/P)	Good

Possible Solutions:

Remove & Replace Detectable Warning System.

R305.2

\$ 800.00
