Access Compliance Report

Public Rights-of-Way

(Curb Ramps)

Intersection ID: 45501	Main Street: BUGGY_HORSE_RD	Cross Street: CAPTAIN_ARDREY_RD	Location: W
ADA ID: A7FA8E33AC72	Ramp Type: PerpDiag	Initial Pass/Fail: Fail	Overall Compliance: No
Severity Score: 42.5			
Codes/Mitigation Info/Possible Solution		Field Measurements/Component Compliance

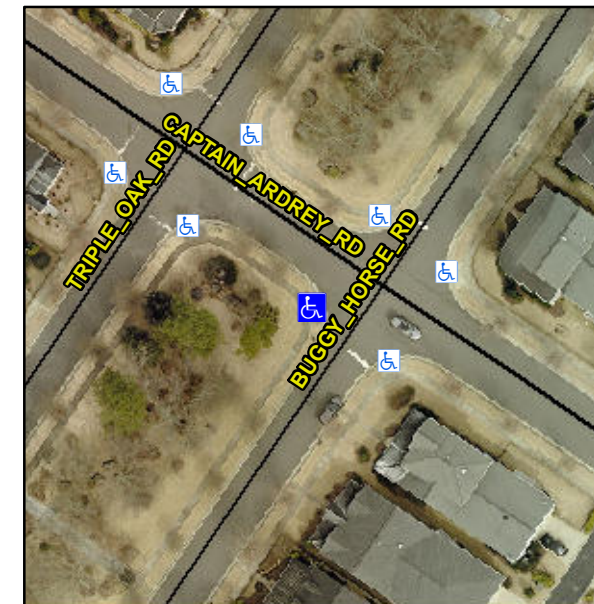
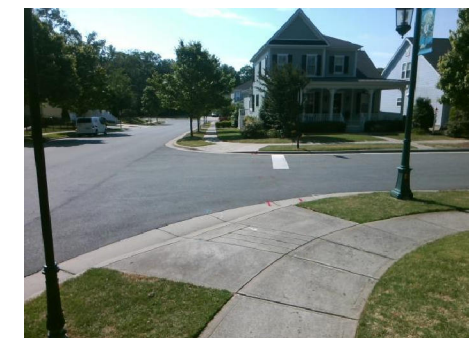
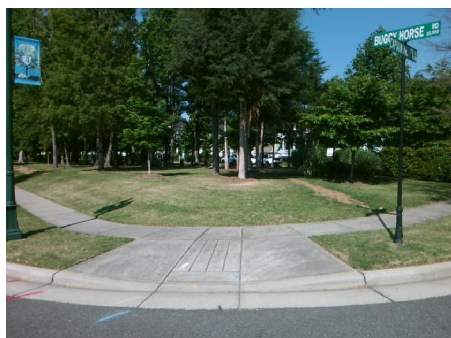
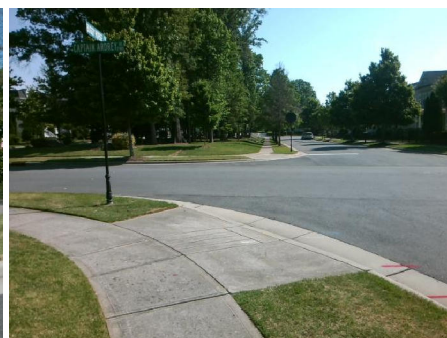
Not Found, R304.5.1, R304.2.2, R304.5.3

Compliance	Description	Data	Compliance	Description	Data
N/A	Ramp Length (in)	71.0	No	Ramp Slope (%)	10.0
No	Ramp Width (in)	35.0	No	Ramp XSlope (%)	5.2
N/A	Flare Type LT	N/A	N/A	Flare Type RT	N/A
N/A	Flare Slope LT (%)	N/A	N/A	Flare Slope RT (%)	N/A
N/A	Flare Traversable LT?	N/A	N/A	Flare Traversable RT?	N/A
N/A	Landing Length (in)	N/A	N/A	DWS Provided?	N/A
N/A	Landing Width (in)	N/A	N/A	DWS Contrast?	N/A
N/A	Landing Slope (%)	N/A	N/A	DWS Length (in)	N/A
N/A	Landing X Slope (%)	N/A	N/A	DWS Full Width?	N/A
N/A	Landing Curb? (Y/N)	N/A	N/A	DWS Offset (in)	N/A
N/A	Shared Landing?	N/A			
N/A	Gutter Ponding?	N/A	N/A	Gutter Slope (%)	N/A
N/A	Gutter Lip Ht (in)	N/A	N/A	Gutter X Slope (%)	N/A
N/A	Painted X Walk1?	No	N/A	Painted X Walk2?	No
	X Walk 1 Direction	To SE		X Walk 2 Direction	To NE
N/A	X Walk 1 Width (in)	N/A	N/A	X Walk 2 Width (in)	N/A
	X Walk 1 Slope (%)	2.3		X Walk 2 Slope (%)	3.0
	X Walk 1 X Slope (%)	0.9		X Walk 2 X Slope (%)	4.8

N/A	Ramp inside XWalk1?	N/A	N/A	Ramp inside XWalk2?	N/A
	Road Slope (%)	4.0	N/A	Clear Space?	N/A
	Road X Slope (%)	4.1	N/A	Clear Space to XWalk (in)	N/A
N/A	Any Obstructions?	N/A	N/A	Storm Grate/Utility Hazard?	N/A
	Obstruction Type			Storm Grate/Utility Type	
		N/A			N/A
			Yes	Surface Condition? (G/P)	Good

Remove & Replace Curb Ramp With Two New Directional Ramps or Equivalent.
