Access Compliance Report

Public Rights-of-Way

(Curb Ramps)

Intersection ID: 14937	Main Street: BRIGHTON_PL	Cross Street: NORLAND_RD	Location:	N
ADA ID: A7FDADC6740A	Ramp Type: Perp	Initial Pass/Fail: Fail	Overall Compliance: No	Severity Score: 25
Codes/Mitigation Info/Possible Solution		Field Measurements/Component Compliance

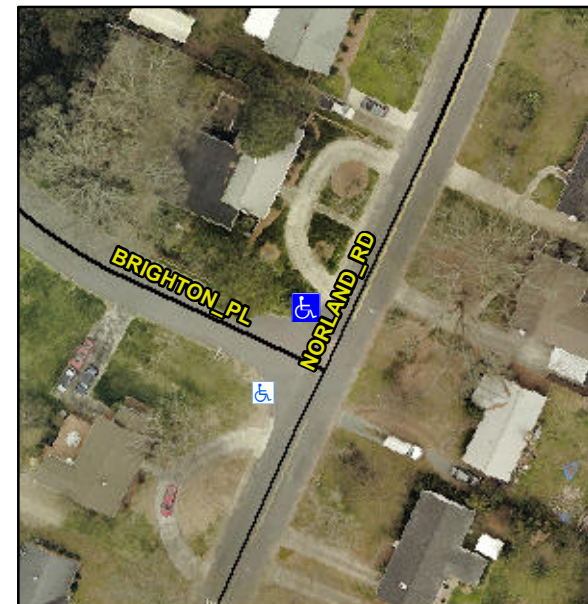
Not Found, R304.2.2, R304.5.3

Compliance	Description	Data	Compliance	Description	Data
N/A	Ramp Length (in)	50.5	No	Ramp Slope (%)	9.3
Yes	Ramp Width (in)	48.0	No	Ramp XSlope (%)	6.5
N/A	Flare Type LT	N/A	N/A	Flare Type RT	N/A
N/A	Flare Slope LT (%)	N/A	N/A	Flare Slope RT (%)	N/A
N/A	Flare Traversable LT?	N/A	N/A	Flare Traversable RT?	N/A
N/A	Landing Length (in)	N/A	N/A	DWS Provided?	N/A
N/A	Landing Width (in)	N/A	N/A	DWS Contrast?	N/A
N/A	Landing Slope (%)	N/A	N/A	DWS Length (in)	N/A
N/A	Landing X Slope (%)	N/A	N/A	DWS Full Width?	N/A
N/A	Landing Curb? (Y/N)	N/A	N/A	DWS Offset (in)	N/A
N/A	Shared Landing?	N/A			
N/A	Gutter Ponding?	N/A	N/A	Gutter Slope (%)	N/A
N/A	Gutter Lip Ht (in)	N/A	N/A	Gutter X Slope (%)	N/A
N/A	Painted X Walk1?	No	N/A	Painted X Walk2?	N/A
	X Walk 1 Direction	To SW		X Walk 2 Direction	N/A
N/A	X Walk 1 Width (in)	N/A	N/A	X Walk 2 Width (in)	N/A
	X Walk 1 Slope (%)	1.7		X Walk 2 Slope (%)	N/A
	X Walk 1 X Slope (%)	7.9		X Walk 2 X Slope (%)	N/A

N/A	Ramp inside XWalk1?	N/A	N/A	Ramp inside XWalk2?	N/A
	Road Slope (%)	N/A	N/A	Clear Space?	N/A
	Road X Slope (%)	N/A	N/A	Clear Space to XWalk (in)	N/A
N/A	Any Obstructions?	N/A	N/A	Storm Grate/Utility Hazard?	N/A
	Obstruction Type			Storm Grate/Utility Type	
		N/A			N/A
			Yes	Surface Condition? (G/P)	Good

Possible Solutions:

Remove & Replace Entire Ramp.

Total Cost: \$ 1850.00
