Access Compliance Report

Public Rights-of-Way

(Curb Ramps)

Intersection ID: 14987	Main Street: HERMITAGE_RD	Cross Street: MORAVIAN_LN	Location: NE
ADA ID: A7FFCEC3C3FA	Ramp Type: Perp	Initial Pass/Fail: Fail	Overall Compliance: No
Severity Score: 35			
Codes/Mitigation Info/Possible Solution		Field Measurements/Component Compliance

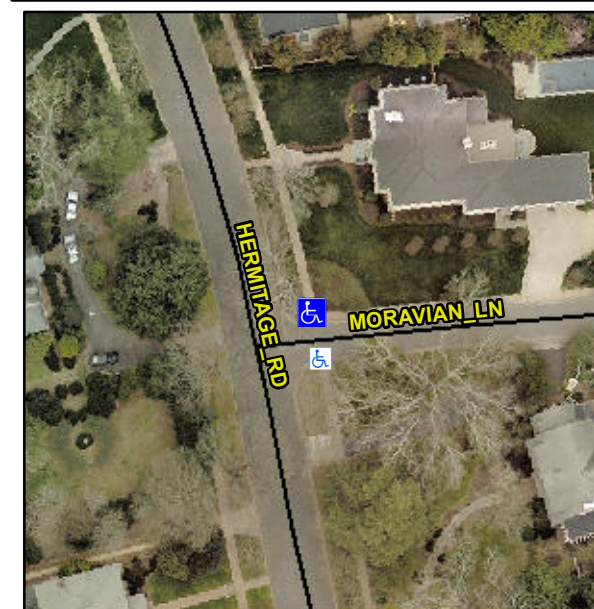
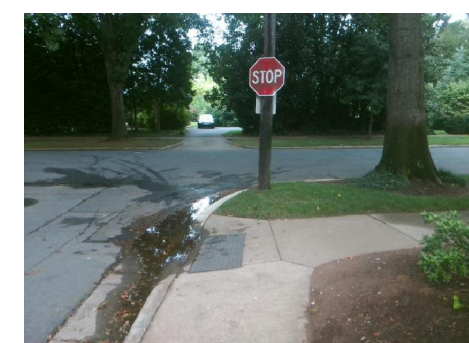
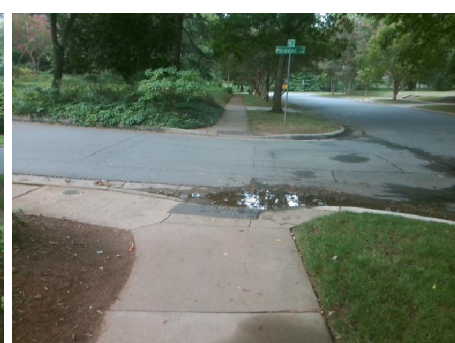
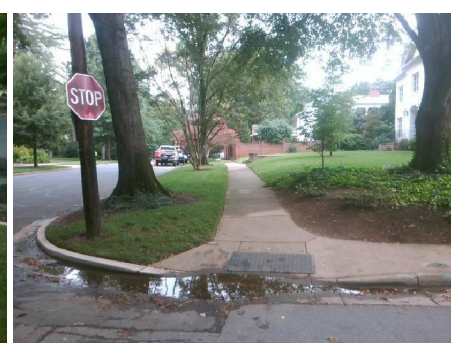
R304.5.1, R304.2.2, R304.5.3

Compliance	Description	Data	Compliance	Description	Data
N/A	Ramp Length (in)	54.0	No	Ramp Slope (%)	14.9
No	Ramp Width (in)	42.0	No	Ramp XSlope (%)	2.3
N/A	Flare Type LT	N/A	N/A	Flare Type RT	N/A
N/A	Flare Slope LT (%)	N/A	N/A	Flare Slope RT (%)	N/A
N/A	Flare Traversable LT?	N/A	N/A	Flare Traversable RT?	N/A
N/A	Landing Length (in)	N/A	N/A	DWS Provided?	N/A
N/A	Landing Width (in)	N/A	N/A	DWS Contrast?	N/A
N/A	Landing Slope (%)	N/A	N/A	DWS Length (in)	N/A
N/A	Landing X Slope (%)	N/A	N/A	DWS Full Width?	N/A
N/A	Landing Curb? (Y/N)	N/A	N/A	DWS Offset (in)	N/A
N/A	Shared Landing?	N/A			
N/A	Gutter Ponding?	Yes	N/A	Gutter Slope (%)	N/A
N/A	Gutter Lip Ht (in)	N/A	N/A	Gutter X Slope (%)	N/A
N/A	Painted X Walk1?	No	N/A	Painted X Walk2?	N/A
	X Walk 1 Direction	To S		X Walk 2 Direction	N/A
N/A	X Walk 1 Width (in)	N/A	N/A	X Walk 2 Width (in)	N/A
	X Walk 1 Slope (%)	0.0		X Walk 2 Slope (%)	N/A
	X Walk 1 X Slope (%)	2.2		X Walk 2 X Slope (%)	N/A

N/A	Ramp inside XWalk1?	N/A	N/A	Ramp inside XWalk2?	N/A
	Road Slope (%)	N/A	N/A	Clear Space?	N/A
	Road X Slope (%)	N/A	N/A	Clear Space to XWalk (in)	N/A
N/A	Any Obstructions?	N/A	N/A	Storm Grate/Utility Hazard?	N/A
	Obstruction Type			Storm Grate/Utility Type	
		N/A			N/A
		Yes		Surface Condition? (G/P)	Good

Remove & Replace Entire Ramp.
