# Access Compliance Report

## Public Rights-of-Way

| Intersection ID: 46179 | Main Street: SEVEN_OAKS_DR | Cross Street: ROCKY_RIVER_RD | Location: SE |
| ADA ID: A80865A1A7F6 | Ramp Type: Directional1 | Initial Pass/Fail: Pass | Overall Compliance: No |

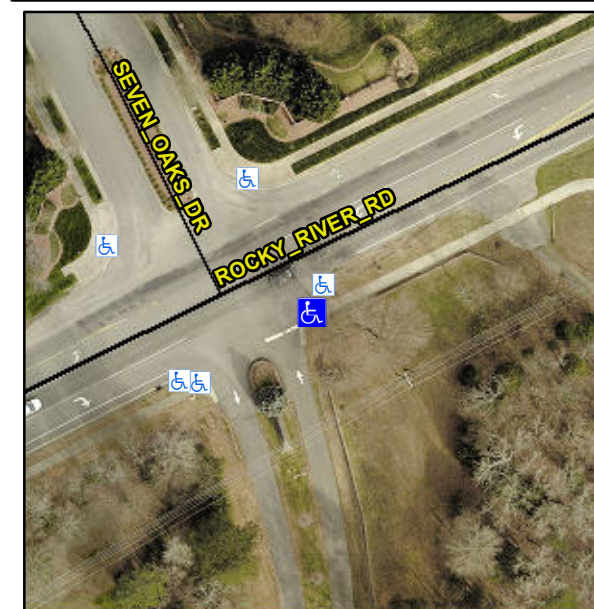
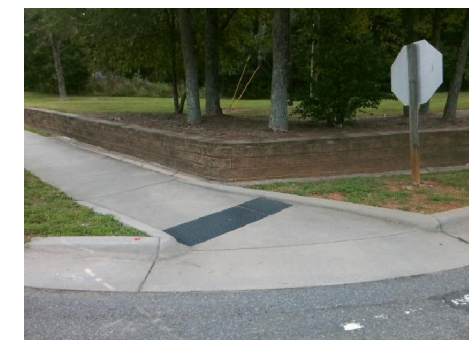
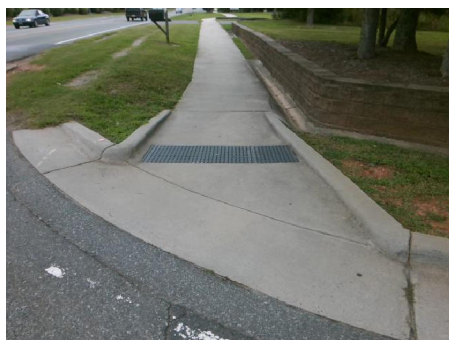
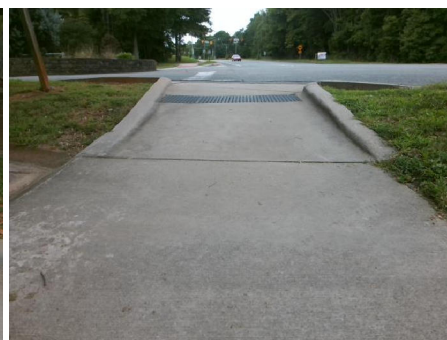
| Severity Score: 5 | | | |

**R304.2.2-Perp, R304.3.2-Para,  
R304.5.3, R304.2.3, R305.2**

| Compliance | Description | Data | Compliance | Description | Data |
|---|---|---|---|---|---|
| Yes | Ramp Width (in) | 66.5 | No | Grade Break Slope (%) | 5.8 |
| Yes | Ramp Slope (%) | 7.6 | No | Grade Break XSlope (%) | 3.3 |
| No | Landing Slope (%) | 3.7 | Yes | DWS Length (in) | 24.5 |
| No | Landing X Slope (%) | 2.9 | Yes | DWS Full Width? | Yes |
| Yes | Gutter Lip Ht (in) | 0.0 | No | Gutter X Slope (%) | 2.6 |

**Remove & Replace Entire Ramp.  
Remove & Replace Gutter.**

Total Cost: \$ 2350.00
