Access Compliance Report

Public Rights-of-Way

(Curb Ramps)

Intersection ID: 43869	Main Street: CALDWELL_RIDGE_PY	Cross Street: SIDNEY_CREST_AV	Location: SW
ADA ID: A808A37BB686	Ramp Type: Perp	Initial Pass/Fail: Fail	Overall Compliance: No
Severity Score: 10			
Codes/Mitigation Info/Possible Solution		Field Measurements/Component Compliance

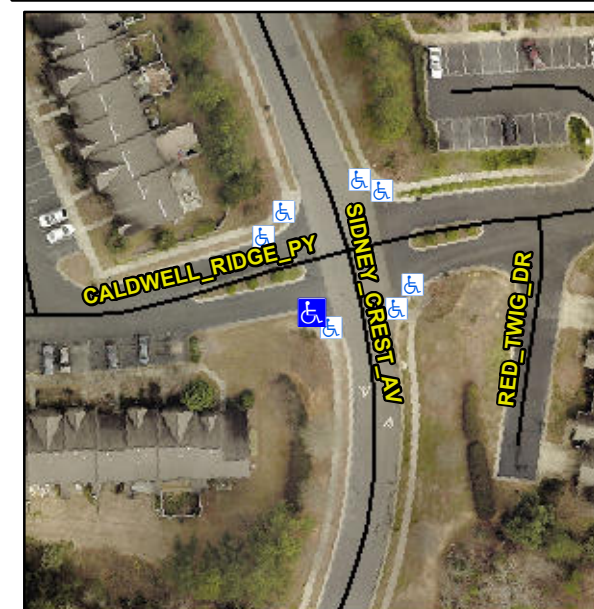
Not Found, R304.5.1, R304.5.3

Compliance	Description	Data	Compliance	Description	Data
N/A	Ramp Length (in)	50.0	Yes	Ramp Slope (%)	5.7
No	Ramp Width (in)	39.5	No	Ramp XSlope (%)	3.9
N/A	Flare Type LT	N/A	N/A	Flare Type RT	N/A
N/A	Flare Slope LT (%)	N/A	N/A	Flare Slope RT (%)	N/A
N/A	Flare Traversable LT?	N/A	N/A	Flare Traversable RT?	N/A
N/A	Landing Length (in)	N/A	N/A	DWS Provided?	N/A
N/A	Landing Width (in)	N/A	N/A	DWS Contrast?	N/A
N/A	Landing Slope (%)	N/A	N/A	DWS Length (in)	N/A
N/A	Landing X Slope (%)	N/A	N/A	DWS Full Width?	N/A
N/A	Landing Curb? (Y/N)	N/A	N/A	DWS Offset (in)	N/A
N/A	Shared Landing?	N/A			
N/A	Gutter Ponding?	N/A	N/A	Gutter Slope (%)	N/A
N/A	Gutter Lip Ht (in)	N/A	N/A	Gutter X Slope (%)	N/A
N/A	Painted X Walk1?	No	N/A	Painted X Walk2?	N/A
	X Walk 1 Direction	To N		X Walk 2 Direction	N/A
N/A	X Walk 1 Width (in)	N/A	N/A	X Walk 2 Width (in)	N/A
	X Walk 1 Slope (%)	0.9		X Walk 2 Slope (%)	N/A
	X Walk 1 X Slope (%)	3.6		X Walk 2 X Slope (%)	N/A

N/A	Ramp inside XWalk1?	N/A	N/A	Ramp inside XWalk2?	N/A
	Road Slope (%)	N/A	N/A	Clear Space?	N/A
	Road X Slope (%)	N/A	N/A	Clear Space to XWalk (in)	N/A
N/A	Any Obstructions?	N/A	N/A	Storm Grate/Utility Hazard?	N/A
	Obstruction Type			Storm Grate/Utility Type	
		N/A			N/A
		Yes		Surface Condition? (G/P)	Good

Remove & Replace Entire Ramp.
