Access Compliance Report

Public Rights-of-Way

(Curb Ramps)

Intersection ID: 42667	Main Street: WALLACE_GLEN_DR	Cross Street: WALLACE_VIEW_CT	Location: NW
ADA ID: A80B2FB58892	Ramp Type: PerpDiag	Initial Pass/Fail: Fail	Overall Compliance: No
Severity Score: 27.5			
Codes/Mitigation Info/Possible Solution		Field Measurements/Component Compliance

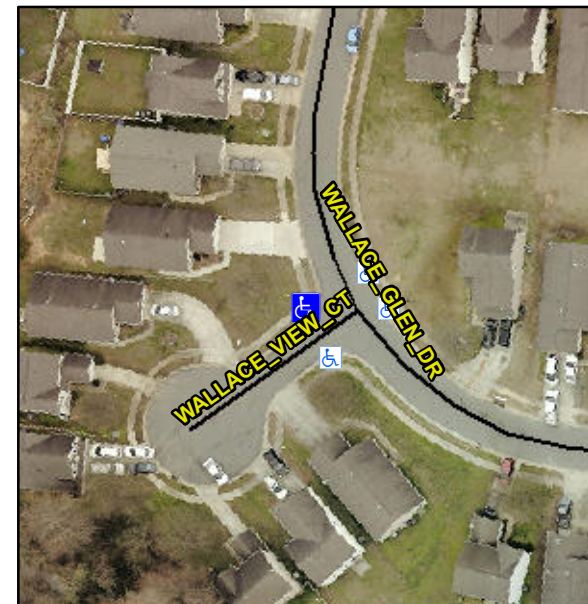
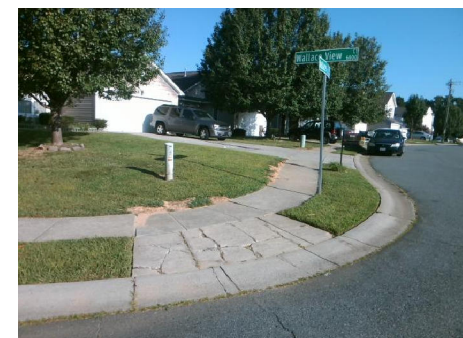
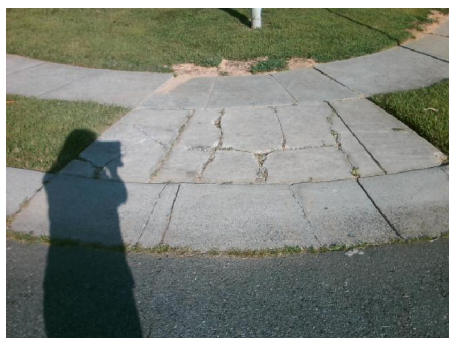
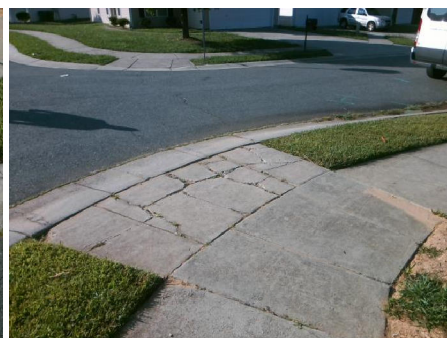
Not Found, R304.5.3, R302.7

Compliance	Description	Data	Compliance	Description	Data
N/A	Ramp Length (in)	50.0	Yes	Ramp Slope (%)	6.0
Yes	Ramp Width (in)	51.0	No	Ramp XSlope (%)	5.8
N/A	Flare Type LT	N/A	N/A	Flare Type RT	N/A
N/A	Flare Slope LT (%)	N/A	N/A	Flare Slope RT (%)	N/A
N/A	Flare Traversable LT?	N/A	N/A	Flare Traversable RT?	N/A
N/A	Landing Length (in)	N/A	N/A	DWS Provided?	N/A
N/A	Landing Width (in)	N/A	N/A	DWS Contrast?	N/A
N/A	Landing Slope (%)	N/A	N/A	DWS Length (in)	N/A
N/A	Landing X Slope (%)	N/A	N/A	DWS Full Width?	N/A
N/A	Landing Curb? (Y/N)	N/A	N/A	DWS Offset (in)	N/A
N/A	Shared Landing?	N/A			
N/A	Gutter Ponding?	N/A	N/A	Gutter Slope (%)	N/A
N/A	Gutter Lip Ht (in)	N/A	N/A	Gutter X Slope (%)	N/A
N/A	Painted X Walk1?	No	N/A	Painted X Walk2?	No
	X Walk 1 Direction	To S		X Walk 2 Direction	To E
N/A	X Walk 1 Width (in)	N/A	N/A	X Walk 2 Width (in)	N/A
	X Walk 1 Slope (%)	0.3		X Walk 2 Slope (%)	5.1
	X Walk 1 X Slope (%)	3.4		X Walk 2 X Slope (%)	3.4

N/A	Ramp inside XWalk1?	N/A	N/A	Ramp inside XWalk2?	N/A
	Road Slope (%)	2.8	N/A	Clear Space?	N/A
	Road X Slope (%)	2.2	N/A	Clear Space to XWalk (in)	N/A
N/A	Any Obstructions?	N/A	N/A	Storm Grate/Utility Hazard?	N/A
	Obstruction Type			Storm Grate/Utility Type	
		N/A			N/A
		No		Surface Condition? (G/P)	Poor

Remove & Replace Curb Ramp With Two New Directional Ramps or Equivalent.

Total Cost: \$ **3200.00**
