Access Compliance Report Public Rights-of-Way (Curb Ramps)

Intersection ID: 10017072 Main Street: UNIVERSITY CITY BV **Cross Street: N/A** Location: W **Overall Compliance: No** ADA ID: A811153F25CC Ramp Type: Directional1 Initial Pass/Fail: Fail **Severity Score:** 12.5

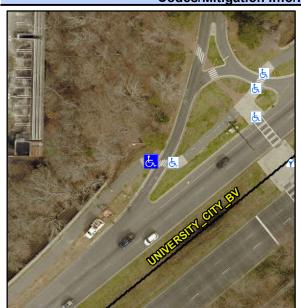
Possible Solutions:	Comp	liance Description
Remove & Replace Entire Ramp.	N/A	Ramp Length (in)
i i	Yes	Ramp Width (in)
	No	Ramp Slope (%)
	Yes	Ramp XSlope (%)
	N/A	Flare Type LT
	N/A	Flare Slope LT (%)
Surveyor Notes:	N/A	Flare Traversable LT
N/A	N/A	Landing Length (in)
	N/A	Landing Width (in)
	N/A	Landing Slope (%)
	N/A	Landing X Slope (%)
PROW/ADA:	N/A	Landing Curb? (Y/N)
R304.2.2	N/A	Shared Landing?
	N/A	Gutter Ponding?
	N/A	Gutter Lip Ht (in)
	N/A	Painted X Walk1?
		X Walk 1 Direction
		X Walk 1 Width (in)
		X Walk 1 Slope (%)
		X Walk 1 X Slope (%
	N/A	Pamp incide VWalks
