# Access Compliance Report

## Public Rights-of-Way

### (Curb Ramps)

Intersection ID: 10023636	Main Street: CLOSEBURN_RD	Cross Street: N/A	Location: S
ADA ID: A81211D0CF49	Ramp Type: PerpDiag	Initial Pass/Fail: Fail	Overall Compliance: No
		Severity Score: 60

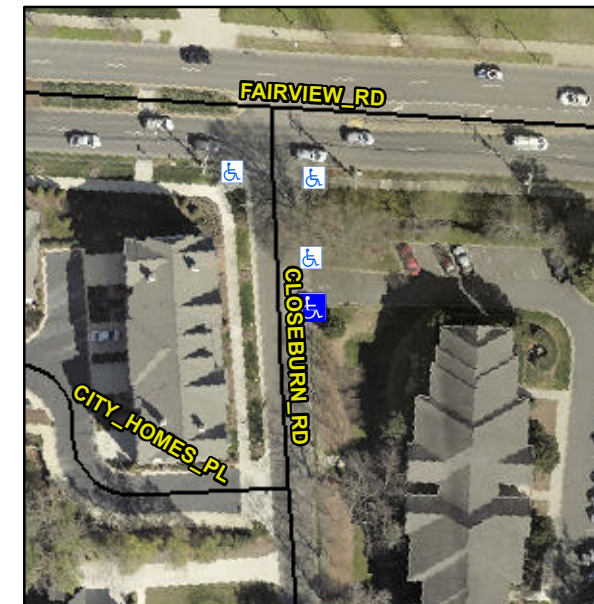
**Not Found, R304.5.1, R304.5.3**

Compliance	Description	Data	Compliance	Description	Data
N/A	Ramp Length (in)	58.0	Yes	Ramp Slope (%)	8.0
No	Ramp Width (in)	25.0	No	Ramp XSlope (%)	7.3
N/A	Flare Type LT	N/A	N/A	Flare Type RT	N/A
N/A	Flare Slope LT (%)	N/A	N/A	Flare Slope RT (%)	N/A
N/A	Flare Traversable LT?	N/A	N/A	Flare Traversable RT?	N/A
N/A	Landing Length (in)	N/A	N/A	DWS Provided?	N/A
N/A	Landing Width (in)	N/A	N/A	DWS Contrast?	N/A
N/A	Landing Slope (%)	N/A	N/A	DWS Length (in)	N/A
N/A	Landing X Slope (%)	N/A	N/A	DWS Full Width?	N/A
N/A	Landing Curb? (Y/N)	N/A	N/A	DWS Offset (in)	N/A
N/A	Shared Landing?	N/A			
N/A	Gutter Ponding?	N/A	N/A	Gutter Slope (%)	N/A
N/A	Gutter Lip Ht (in)	N/A	N/A	Gutter X Slope (%)	N/A
N/A	Painted X Walk1?	No	N/A	Painted X Walk2?	No
	X Walk 1 Direction	To N		X Walk 2 Direction	To W
N/A	X Walk 1 Width (in)	N/A	N/A	X Walk 2 Width (in)	N/A
	X Walk 1 Slope (%)	2.5		X Walk 2 Slope (%)	0.1
	X Walk 1 X Slope (%)	9.0		X Walk 2 X Slope (%)	0.7

N/A	Ramp inside XWalk1?	N/A	N/A	Ramp inside XWalk2?	N/A
	Road Slope (%)	2.6	N/A	Clear Space?	N/A
	Road X Slope (%)	4.4	N/A	Clear Space to XWalk (in)	N/A
N/A	Any Obstructions?	N/A	N/A	Storm Grate/Utility Hazard?	N/A
	Obstruction Type			Storm Grate/Utility Type	
		N/A			N/A
			Yes	Surface Condition? (G/P)	Good

**Remove & Replace Curb Ramp With Two New Directional Ramps or Equivalent.**

Total Cost: \$ 3200.00
