# Access Compliance Report

## Public Rights-of-Way

### (Curb Ramps)

Intersection ID: 6867	Main Street: BUFFALO_VALLEY_DR	Cross Street: WINDING_CANYON_DR	Location:	N/A
ADA ID: A815A9767D54	Ramp Type: BlendTrans1	Initial Pass/Fail: Fail	Overall Compliance: No	Severity Score: 25

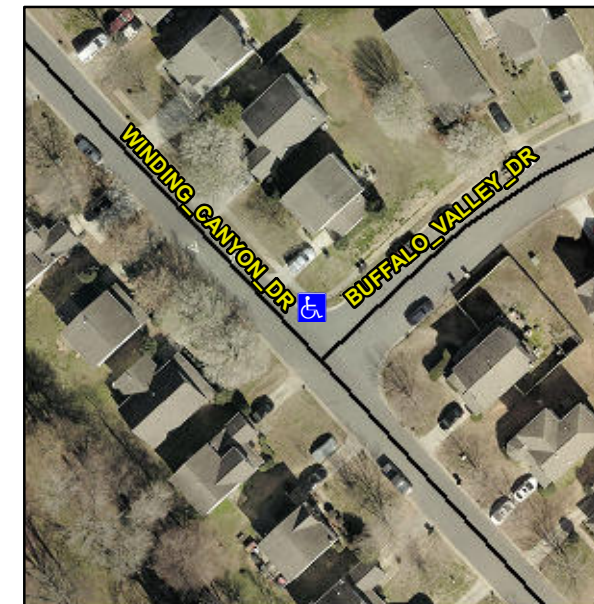
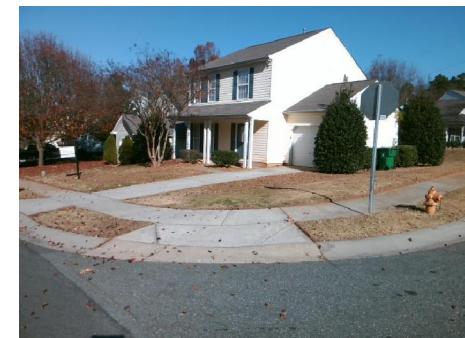
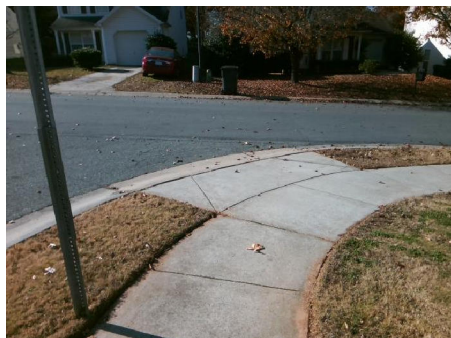
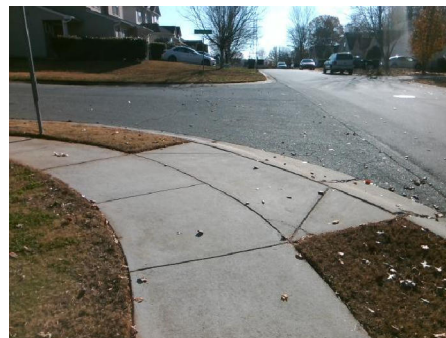
**Not Found, R304.5.3**

Compliance	Description	Data	Compliance	Description	Data
N/A	Ramp Length (in)	48.5	Yes	BlendTrans Slope (%)	4.7
Yes	Ramp Width (in)	48.0	No	BlendTrans XSlope (%)	7.0
N/A	Flare Type LT	N/A	N/A	Flare Type RT	N/A
N/A	Flare Slope LT (%)	N/A	N/A	Flare Slope RT (%)	N/A
N/A	Flare Traversable LT?	N/A	N/A	Flare Traversable RT?	N/A
N/A	Landing Length (in)	N/A	N/A	DWS Provided?	N/A
N/A	Landing Width (in)	N/A	N/A	DWS Contrast?	N/A
N/A	Landing Slope (%)	N/A	N/A	DWS Length (in)	N/A
N/A	Landing X Slope (%)	N/A	N/A	DWS Full Width?	N/A
N/A	Landing Curb? (Y/N)	N/A	N/A	DWS Offset (in)	N/A
N/A	Shared Landing?	N/A			
N/A	Gutter Ponding?	N/A	N/A	Gutter Slope (%)	N/A
N/A	Gutter Lip Ht (in)	N/A	N/A	Gutter X Slope (%)	N/A
N/A	Painted X Walk1?	No	N/A	Painted X Walk2?	No
	X Walk 1 Direction	To SW		X Walk 2 Direction	To SE
	X Walk 1 Width (in)	N/A		X Walk 2 Width (in)	N/A
	X Walk 1 Slope (%)	1.6		X Walk 2 Slope (%)	N/A
	X Walk 1 X Slope (%)	5.5		X Walk 2 X Slope (%)	N/A

N/A	Ramp inside XWalk1?	N/A	N/A	Ramp inside XWalk2?	N/A
	Road Slope (%)	5.5		Clear Space?	N/A
	Road X Slope (%)	1.6	N/A	Clear Space to XWalk (in)	N/A
N/A	Any Obstructions?	N/A	N/A	Storm Grate/Utility Hazard?	N/A
	Obstruction Type			Storm Grate/Utility Type	
		N/A			N/A
			Yes	Surface Condition? (G/P)	Good
			No	Curb Slope (%)	14.2

**Remove & Replace Curb Ramp With Two New Directional Ramps or Equivalent.**
