Access Compliance Report

Public Rights-of-Way

(Curb Ramps)

Intersection ID: 14763	Main Street: HERMITAGE_RD	Cross Street: QUEENS_RD	Location: SE
ADA ID: A817956679F3	Ramp Type: Perp	Initial Pass/Fail: Fail	Overall Compliance: No
Severity Score: 37.5			
Codes/Mitigation Info/Possible Solution		Field Measurements/Component Compliance

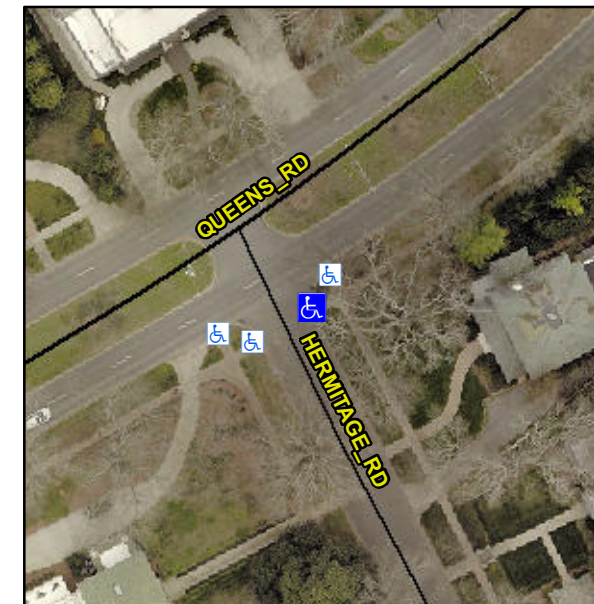
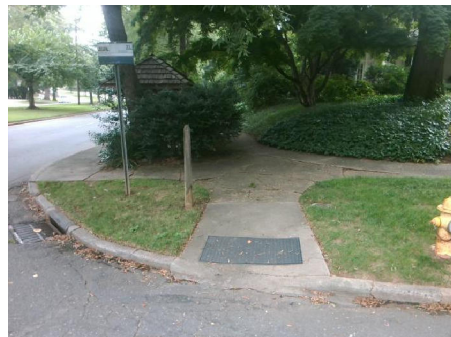
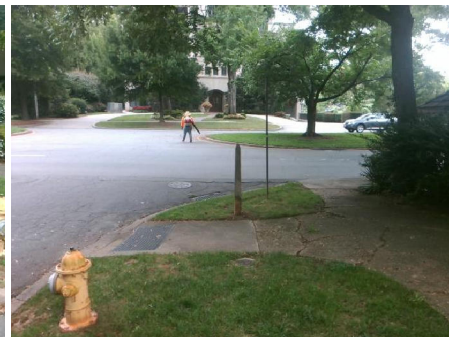
Not Found, R304.2.2, R304.5.3

Compliance	Description	Data	Compliance	Description	Data
N/A	Ramp Length (in)	78.0	No	Ramp Slope (%)	10.1
Yes	Ramp Width (in)	48.0	No	Ramp XSlope (%)	8.5
N/A	Flare Type LT	N/A	N/A	Flare Type RT	N/A
N/A	Flare Slope LT (%)	N/A	N/A	Flare Slope RT (%)	N/A
N/A	Flare Traversable LT?	N/A	N/A	Flare Traversable RT?	N/A
N/A	Landing Length (in)	N/A	N/A	DWS Provided?	N/A
N/A	Landing Width (in)	N/A	N/A	DWS Contrast?	N/A
N/A	Landing Slope (%)	N/A	N/A	DWS Length (in)	N/A
N/A	Landing X Slope (%)	N/A	N/A	DWS Full Width?	N/A
N/A	Landing Curb? (Y/N)	N/A	N/A	DWS Offset (in)	N/A
N/A	Shared Landing?	N/A			
N/A	Gutter Ponding?	N/A	N/A	Gutter Slope (%)	N/A
N/A	Gutter Lip Ht (in)	N/A	N/A	Gutter X Slope (%)	N/A
N/A	Painted X Walk1?	No	N/A	Painted X Walk2?	N/A
	X Walk 1 Direction	To SW		X Walk 2 Direction	N/A
N/A	X Walk 1 Width (in)	N/A	N/A	X Walk 2 Width (in)	N/A
	X Walk 1 Slope (%)	3.4		X Walk 2 Slope (%)	N/A
	X Walk 1 X Slope (%)	1.3		X Walk 2 X Slope (%)	N/A

N/A	Ramp inside XWalk1?	N/A	N/A	Ramp inside XWalk2?	N/A
	Road Slope (%)	N/A	N/A	Clear Space?	N/A
	Road X Slope (%)	N/A	N/A	Clear Space to XWalk (in)	N/A
N/A	Any Obstructions?	N/A	N/A	Storm Grate/Utility Hazard?	N/A
	Obstruction Type			Storm Grate/Utility Type	
		N/A			N/A
			Yes	Surface Condition? (G/P)	Good

Possible Solutions:

Remove & Replace Entire Ramp.

Total Cost: \$ 1850.00
