Intersection ID: 10026312	Main Street: FAIRVIEW_RD	Cross Street: N/A	Location:	SW
ADA ID: A824E5B70F93	Ramp Type: ParaDiag	Initial Pass/Fail: Fail	Overall Compliance: No	Severity Score: 13.75

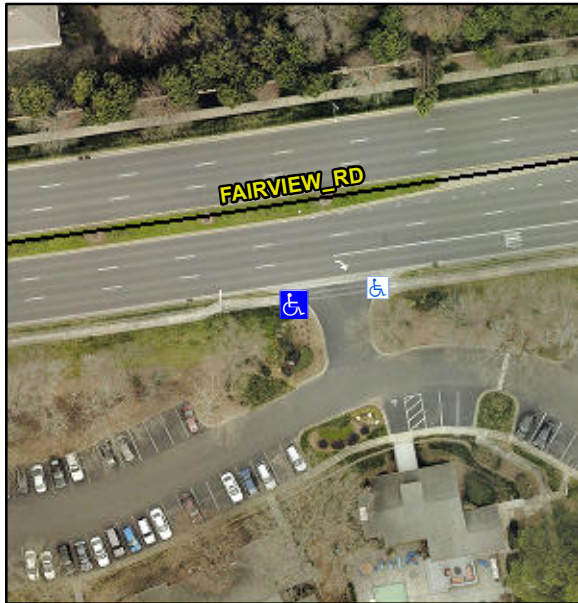
LT RP < 5%

R304.5.3, R304.3.2

Compliance	Description	Data	Compliance	Description	Data
N/A	Ramp Length LT (in)	60.0	N/A	Ramp Length RT (in)	61.0
Yes	Ramp Width LT (in)	59.0	Yes	Ramp Width RT (in)	59.0
Yes	Ramp Slope LT (%)	4.9	No	Ramp Slope RT (%)	9.9
No	Ramp XSlope LT (%)	2.1	No	Ramp XSlope RT (%)	2.1
N/A	Landing Length (in)	N/A	N/A	DWS Provided?	N/A
N/A	Landing Width (in)	N/A	N/A	DWS Contrast?	N/A
N/A	Landing Slope (%)	N/A	N/A	DWS Length (in)	N/A
N/A	Landing X Slope (%)	N/A	N/A	DWS Full Width?	N/A
N/A	Landing Curb? (Y/N)	N/A	N/A	DWS Offset (in)	N/A
N/A	Shared Landing?	N/A			
N/A	Gutter Ponding?	N/A	N/A	Gutter Slope (%)	N/A
N/A	Gutter Lip Ht (in)	N/A	N/A	Gutter X Slope (%)	N/A
N/A	Painted X Walk1?	No	N/A	Painted X Walk2?	No
	X Walk 1 Direction	To E		X Walk 2 Direction	To N
N/A	X Walk 1 Width (in)	N/A	N/A	X Walk 2 Width (in)	N/A
	X Walk 1 Slope (%)	2.0		X Walk 2 Slope (%)	5.2
	X Walk 1 X Slope (%)	6.4		X Walk 2 X Slope (%)	1.4
N/A	Ramp inside XWalk1?	N/A	N/A	Ramp inside XWalk2?	N/A

Road Slope (%)	5.2	N/A	Clear Space?	N/A
	Road X Slope (%)	4.9	N/A	Clear Space to XWalk (in)	N/A
N/A	Any Obstructions?	N/A	N/A	Storm Grate/Utility Hazard?	N/A
	Obstruction Type			Storm Grate/Utility Type	
		N/A			N/A
			Yes	Surface Condition? (G/P)	Good
			N/A	Curb Slope (%)	0.3

Remove & Replace Curb Ramp With Two New Directional Ramps or Equivalent.
