Access Compliance Report

Public Rights-of-Way

(Curb Ramps)

Intersection ID: 27426	Main Street: MEADOW_RUN_LN	Cross Street: SUNINGHURST_LN	Location: S
ADA ID: A82A6FAE276F	Ramp Type: BlendTrans2	Initial Pass/Fail: Fail	Overall Compliance: No
Severity Score: 21.25			
Codes/Mitigation Info/Possible Solution		Field Measurements/Component Compliance

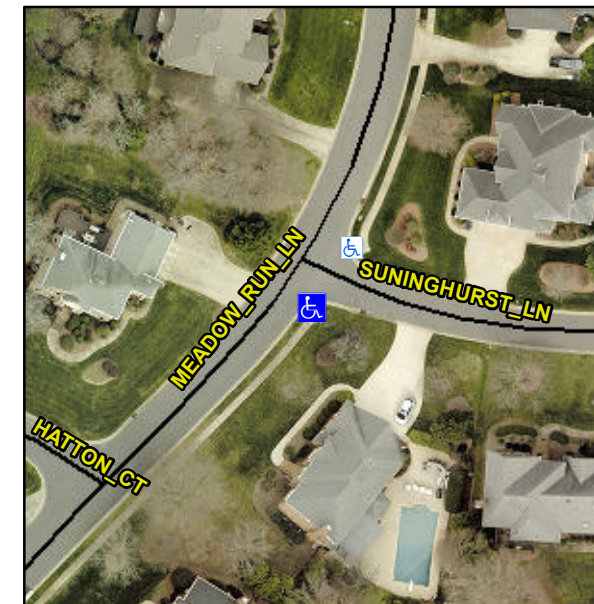
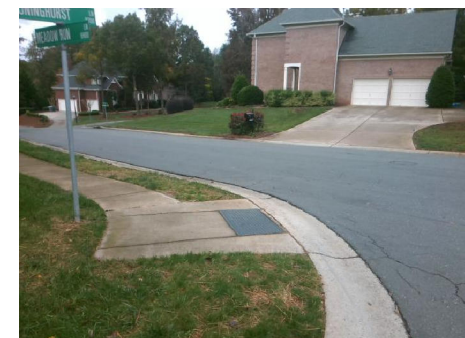
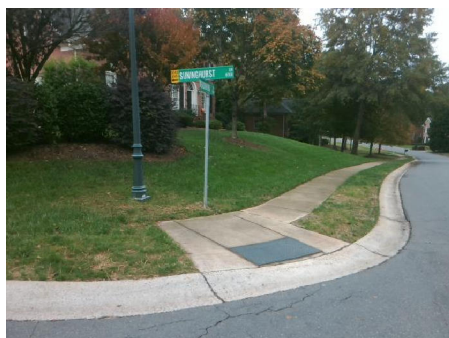
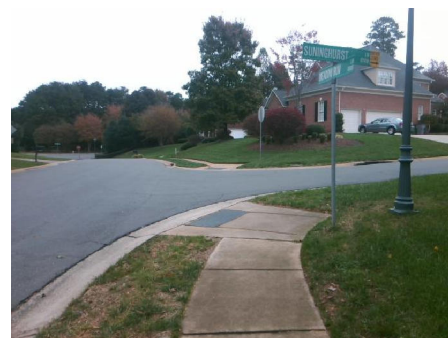
Compliance	Description	Data	Compliance	Description	Data
N/A	Ramp Length (in)	93.0	Yes	BlendTrans Slope (%)	3.5
No	Ramp Width (in)	47.0	No	BlendTrans XSlope (%)	6.5
N/A	Flare Type LT	N/A	N/A	Flare Type RT	N/A
N/A	Flare Slope LT (%)	N/A	N/A	Flare Slope RT (%)	N/A
N/A	Flare Traversable LT?	N/A	N/A	Flare Traversable RT?	N/A
N/A	Landing Length (in)	N/A	N/A	DWS Provided?	N/A
N/A	Landing Width (in)	N/A	N/A	DWS Contrast?	N/A
N/A	Landing Slope (%)	N/A	N/A	DWS Length (in)	N/A
N/A	Landing X Slope (%)	N/A	N/A	DWS Full Width?	N/A
N/A	Landing Curb? (Y/N)	N/A	N/A	DWS Offset (in)	N/A
N/A	Shared Landing?	N/A			
N/A	Gutter Ponding?	N/A	N/A	Gutter Slope (%)	N/A
N/A	Gutter Lip Ht (in)	N/A	N/A	Gutter X Slope (%)	N/A
N/A	Painted X Walk1?	No	N/A	Painted X Walk2?	No
	X Walk 1 Direction	To NE		X Walk 2 Direction	To NW
	X Walk 1 Width (in)	N/A		X Walk 2 Width (in)	N/A
	X Walk 1 Slope (%)	3.4		X Walk 2 Slope (%)	1.5
	X Walk 1 X Slope (%)	4.5		X Walk 2 X Slope (%)	4.3

N/A	Ramp inside XWalk1?	N/A	N/A	Ramp inside XWalk2?	N/A
	Road Slope (%)	6.1		Clear Space?	N/A
	Road X Slope (%)	0.3	N/A	Clear Space to XWalk (in)	N/A
N/A	Any Obstructions?	N/A	N/A	Storm Grate/Utility Hazard?	N/A
	Obstruction Type			Storm Grate/Utility Type	
		N/A			N/A
			Yes	Surface Condition? (G/P)	Good
			N/A	Curb Slope (%)	0.9

Remove & Replace Curb Ramp With Two New Directional Ramps or Equivalent.

R304.5.1, R304.5.3
