# Access Compliance Report

## Public Rights-of-Way

### (Curb Ramps)

Intersection ID: 10031762	Main Street: MIDWAY_PARK_DR	Cross Street: N/A	Location: E
ADA ID: A82D6C7EB9DE	Ramp Type: Perp	Initial Pass/Fail: Fail	Overall Compliance: No
Severity Score: 12.5			
Codes/Mitigation Info/Possible Solution		Field Measurements/Component Compliance

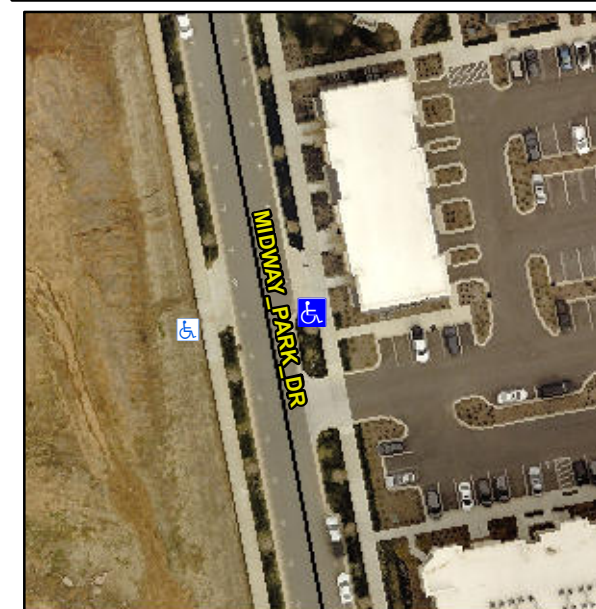
Compliance	Description	Data	Compliance	Description	Data
N/A	Ramp Length (in)	50.0	No	Ramp Slope (%)	8.4
Yes	Ramp Width (in)	58.5	Yes	Ramp XSlope (%)	1.2
N/A	Flare Type LT	N/A	N/A	Flare Type RT	N/A
N/A	Flare Slope LT (%)	N/A	N/A	Flare Slope RT (%)	N/A
N/A	Flare Traversable LT?	N/A	N/A	Flare Traversable RT?	N/A
N/A	Landing Length (in)	N/A	N/A	DWS Provided?	N/A
N/A	Landing Width (in)	N/A	N/A	DWS Contrast?	N/A
N/A	Landing Slope (%)	N/A	N/A	DWS Length (in)	N/A
N/A	Landing X Slope (%)	N/A	N/A	DWS Full Width?	N/A
N/A	Landing Curb? (Y/N)	N/A	N/A	DWS Offset (in)	N/A
N/A	Shared Landing?	N/A			
N/A	Gutter Ponding?	N/A	N/A	Gutter Slope (%)	N/A
N/A	Gutter Lip Ht (in)	N/A	N/A	Gutter X Slope (%)	N/A
N/A	Painted X Walk1?	No	N/A	Painted X Walk2?	N/A
	X Walk 1 Direction	To W		X Walk 2 Direction	N/A
N/A	X Walk 1 Width (in)	N/A	N/A	X Walk 2 Width (in)	N/A
	X Walk 1 Slope (%)	2.4		X Walk 2 Slope (%)	N/A
	X Walk 1 X Slope (%)	1.1		X Walk 2 X Slope (%)	N/A

N/A	Ramp inside XWalk1?	N/A	N/A	Ramp inside XWalk2?	N/A
	Road Slope (%)	N/A	N/A	Clear Space?	N/A
	Road X Slope (%)	N/A	N/A	Clear Space to XWalk (in)	N/A
N/A	Any Obstructions?	N/A	N/A	Storm Grate/Utility Hazard?	N/A
	Obstruction Type			Storm Grate/Utility Type	
		N/A			N/A
			Yes	Surface Condition? (G/P)	Good

Possible Solutions:

**Remove & Replace Entire Ramp.**

**R304.2.2**
