Access Compliance Report

Public Rights-of-Way (Curb Ramps)

Intersection ID: 30016	Main Street: KEMPSFORD_DR	Cross Street: LUTON_CT	Location: W
ADA ID: A831236CAAEF	Ramp Type: Perp	Initial Pass/Fail: Fail	Overall Compliance: No
Codes/Mitigation Info/Possible Solution		Field Measurements/Component Compliance	
Severity Score: 8.75

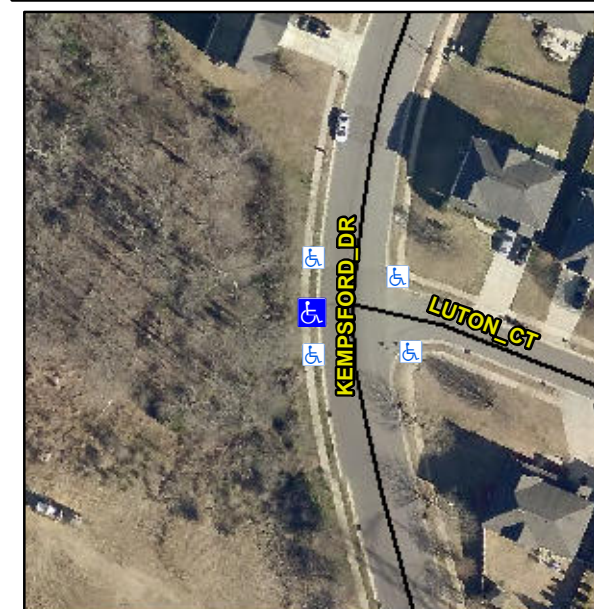
Not Found, R304.5.1

Compliance	Description	Data	Compliance	Description	Data
N/A	Ramp Length (in)	50.0	Yes	Ramp Slope (%)	5.0
No	Ramp Width (in)	40.5	Yes	Ramp XSlope (%)	1.6
N/A	Flare Type LT	N/A	N/A	Flare Type RT	N/A
N/A	Flare Slope LT (%)	N/A	N/A	Flare Slope RT (%)	N/A
N/A	Flare Traversable LT?	N/A	N/A	Flare Traversable RT?	N/A
N/A	Landing Length (in)	N/A	N/A	DWS Provided?	N/A
N/A	Landing Width (in)	N/A	N/A	DWS Contrast?	N/A
N/A	Landing Slope (%)	N/A	N/A	DWS Length (in)	N/A
N/A	Landing X Slope (%)	N/A	N/A	DWS Full Width?	N/A
N/A	Landing Curb? (Y/N)	N/A	N/A	DWS Offset (in)	N/A
N/A	Shared Landing?	N/A			
N/A	Gutter Ponding?	N/A	N/A	Gutter Slope (%)	N/A
N/A	Gutter Lip Ht (in)	N/A	N/A	Gutter X Slope (%)	N/A
N/A	Painted X Walk1?	No	N/A	Painted X Walk2?	N/A
	X Walk 1 Direction	To SE		X Walk 2 Direction	N/A
N/A	X Walk 1 Width (in)	N/A	N/A	X Walk 2 Width (in)	N/A
	X Walk 1 Slope (%)	2.5		X Walk 2 Slope (%)	N/A
	X Walk 1 X Slope (%)	3.2		X Walk 2 X Slope (%)	N/A

N/A	Ramp inside XWalk1?	N/A	N/A	Ramp inside XWalk2?	N/A
	Road Slope (%)	N/A	N/A	Clear Space?	N/A
	Road X Slope (%)	N/A	N/A	Clear Space to XWalk (in)	N/A
N/A	Any Obstructions?	N/A	N/A	Storm Grate/Utility Hazard?	N/A
	Obstruction Type			Storm Grate/Utility Type	
		N/A			N/A
			Yes	Surface Condition? (G/P)	Good

Remove & Replace Entire Ramp.
