# Access Compliance Report

## Public Rights-of-Way

### (Curb Ramps)

Intersection ID: 42459	Main Street: KINGSLEY_VIEW_DR	Cross Street: KING_LOUIS_CT	Location: SE
ADA ID: A8457FD71431	Ramp Type: PerpDiag	Initial Pass/Fail: Fail	Overall Compliance: No
Severity Score: 22.5			
Codes/Mitigation Info/Possible Solution		Field Measurements/Component Compliance

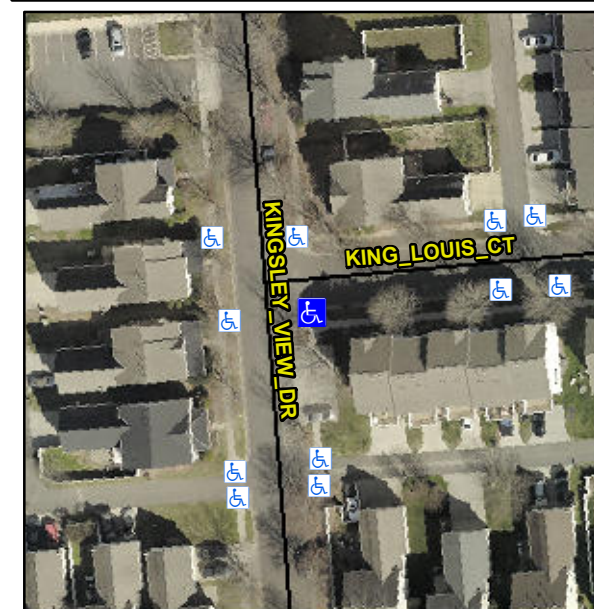
Compliance	Description	Data	Compliance	Description	Data
N/A	Ramp Length (in)	74.0	No	Ramp Slope (%)	9.0
No	Ramp Width (in)	38.0	Yes	Ramp XSlope (%)	2.1
N/A	Flare Type LT	N/A	N/A	Flare Type RT	N/A
N/A	Flare Slope LT (%)	N/A	N/A	Flare Slope RT (%)	N/A
N/A	Flare Traversable LT?	N/A	N/A	Flare Traversable RT?	N/A
N/A	Landing Length (in)	N/A	N/A	DWS Provided?	N/A
N/A	Landing Width (in)	N/A	N/A	DWS Contrast?	N/A
N/A	Landing Slope (%)	N/A	N/A	DWS Length (in)	N/A
N/A	Landing X Slope (%)	N/A	N/A	DWS Full Width?	N/A
N/A	Landing Curb? (Y/N)	N/A	N/A	DWS Offset (in)	N/A
N/A	Shared Landing?	N/A			
N/A	Gutter Ponding?	N/A	N/A	Gutter Slope (%)	N/A
N/A	Gutter Lip Ht (in)	N/A	N/A	Gutter X Slope (%)	N/A
N/A	Painted X Walk1?	No	N/A	Painted X Walk2?	No
	X Walk 1 Direction	To N		X Walk 2 Direction	To W
N/A	X Walk 1 Width (in)	N/A	N/A	X Walk 2 Width (in)	N/A
	X Walk 1 Slope (%)	1.3		X Walk 2 Slope (%)	2.8
	X Walk 1 X Slope (%)	1.5		X Walk 2 X Slope (%)	2.0

N/A	Ramp inside XWalk1?	N/A	N/A	Ramp inside XWalk2?	N/A
	Road Slope (%)	2.1	N/A	Clear Space?	N/A
	Road X Slope (%)	0.1	N/A	Clear Space to XWalk (in)	N/A
N/A	Any Obstructions?	N/A	N/A	Storm Grate/Utility Hazard?	N/A
	Obstruction Type			Storm Grate/Utility Type	
		N/A			N/A
		Yes		Surface Condition? (G/P)	Good

Possible Solutions:

**Remove & Replace Curb Ramp With Two New Directional Ramps or Equivalent.**

**R304.5.1, R304.2.2**
