## **Access Compliance Report Public Rights-of-Way** (Curb Ramps)

Intersection ID: 48426 Main Street: EVANTON LOCH RD **Cross Street: ROUSAY RD** Location: NW ADA ID: A8471F66A972 Ramp Type: PerpDiag Initial Pass/Fail: Fail **Overall Compliance: No** Severity Score: 21.25

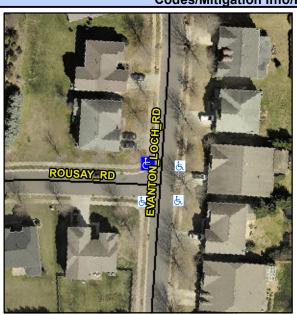
| Field Measurements/Component Compliance | | | | | |
|---|---|---|---|---|---|
| No | Ramp Width (in) | 46.5 | No | Ramp XSlope (%) | 5.4 |

Possible Solutions: Remove & Replace Curb Ramp With Two New Directional Ramps or Equivalent. Surveyor Notes: N/A PROW/ADA: Not Found, R304.5.1, R304.5.3
