Access Compliance Report

Public Rights-of-Way

(Curb Ramps)

Intersection ID: 7486	Main Street: TRYON_ST	Cross Street: OWEN_ST	Location: NW
ADA ID: A84A25AE9B96	Ramp Type: Perp	Initial Pass/Fail: Fail	Overall Compliance: No
Severity Score: 12.5			
Codes/Mitigation Info/Possible Solution		Field Measurements/Component Compliance

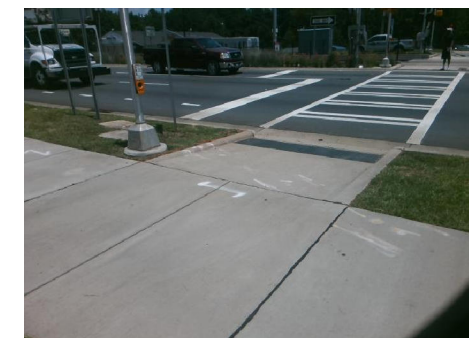
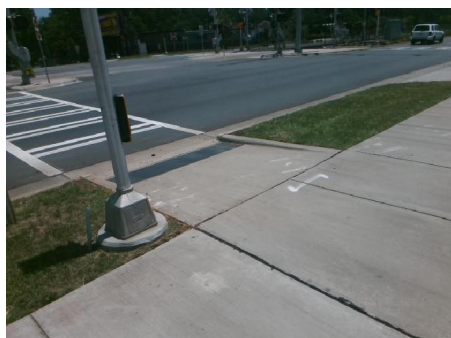
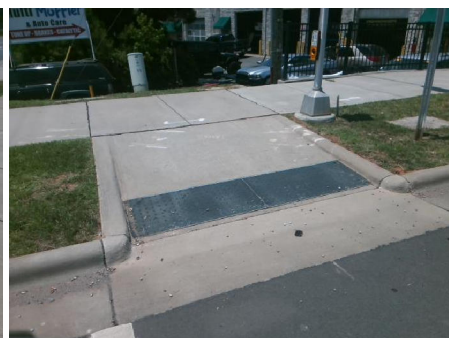
Compliance	Description	Data	Compliance	Description	Data
N/A	Ramp Length (in)	97.0	No	Ramp Slope (%)	8.9
Yes	Ramp Width (in)	94.0	Yes	Ramp XSlope (%)	1.0
N/A	Flare Type LT	N/A	N/A	Flare Type RT	N/A
N/A	Flare Slope LT (%)	N/A	N/A	Flare Slope RT (%)	N/A
N/A	Flare Traversable LT?	N/A	N/A	Flare Traversable RT?	N/A
N/A	Landing Length (in)	N/A	N/A	DWS Provided?	N/A
N/A	Landing Width (in)	N/A	N/A	DWS Contrast?	N/A
N/A	Landing Slope (%)	N/A	N/A	DWS Length (in)	N/A
N/A	Landing X Slope (%)	N/A	N/A	DWS Full Width?	N/A
N/A	Landing Curb? (Y/N)	N/A	N/A	DWS Offset (in)	N/A
N/A	Shared Landing?	N/A			
N/A	Gutter Ponding?	N/A	N/A	Gutter Slope (%)	N/A
N/A	Gutter Lip Ht (in)	N/A	N/A	Gutter X Slope (%)	N/A
N/A	Painted X Walk1?	Yes	N/A	Painted X Walk2?	N/A
	X Walk 1 Direction	To E		X Walk 2 Direction	N/A
N/A	X Walk 1 Width (in)	106.0	N/A	X Walk 2 Width (in)	N/A
	X Walk 1 Slope (%)	2.3		X Walk 2 Slope (%)	N/A
	X Walk 1 X Slope (%)	0.1		X Walk 2 X Slope (%)	N/A

N/A	Ramp inside XWalk1?	Yes	N/A	Ramp inside XWalk2?	N/A
	Road Slope (%)	N/A	N/A	Clear Space?	N/A
	Road X Slope (%)	N/A	N/A	Clear Space to XWalk (in)	N/A
N/A	Any Obstructions?	N/A	N/A	Storm Grate/Utility Hazard?	N/A
	Obstruction Type			Storm Grate/Utility Type	
		N/A			N/A
		Yes		Surface Condition? (G/P)	Good

Possible Solutions:

Remove & Replace Entire Ramp.
