Access Compliance Report

Public Rights-of-Way

(Curb Ramps)

Intersection ID: 18567	Main Street: MICHAEL_BAKER_PL	Cross Street: RUNNYMEDE_LN	Location: NW
ADA ID: A8607CE2B037	Ramp Type: Perp	Initial Pass/Fail: Fail	Overall Compliance: No
		Severity Score: 12.5

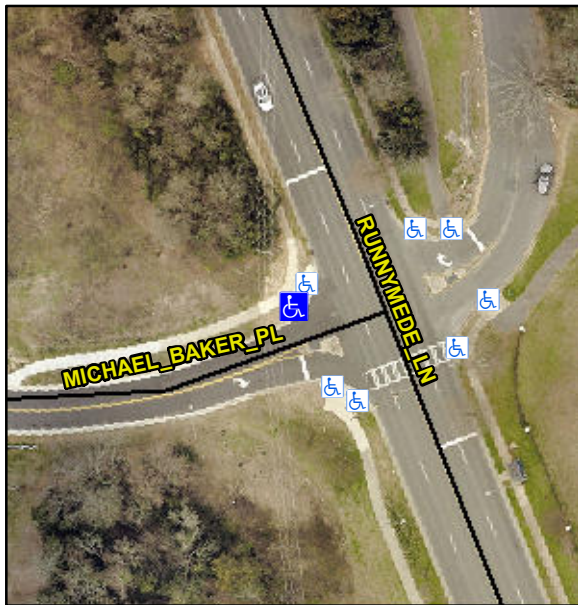
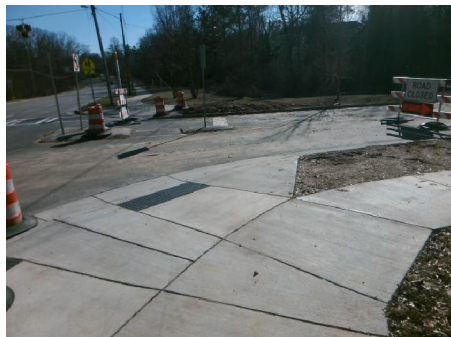
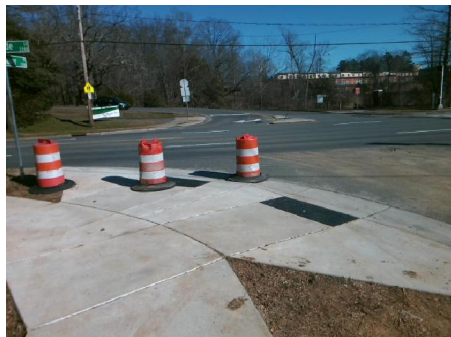
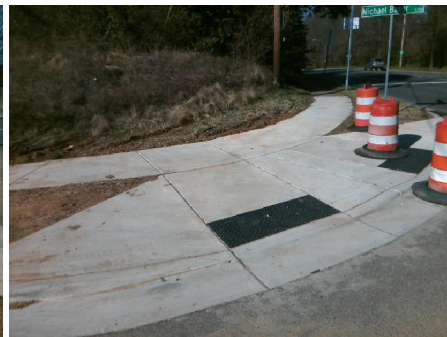
Not Found, R304.2.2

Compliance	Description	Data	Compliance	Description	Data
N/A	Ramp Length (in)	93.0	No	Ramp Slope (%)	9.7
Yes	Ramp Width (in)	59.0	Yes	Ramp XSlope (%)	0.3
N/A	Flare Type LT	N/A	N/A	Flare Type RT	N/A
N/A	Flare Slope LT (%)	N/A	N/A	Flare Slope RT (%)	N/A
N/A	Flare Traversable LT?	N/A	N/A	Flare Traversable RT?	N/A
N/A	Landing Length (in)	N/A	N/A	DWS Provided?	N/A
N/A	Landing Width (in)	N/A	N/A	DWS Contrast?	N/A
N/A	Landing Slope (%)	N/A	N/A	DWS Length (in)	N/A
N/A	Landing X Slope (%)	N/A	N/A	DWS Full Width?	N/A
N/A	Landing Curb? (Y/N)	N/A	N/A	DWS Offset (in)	N/A
N/A	Shared Landing?	N/A			
N/A	Gutter Ponding?	N/A	N/A	Gutter Slope (%)	N/A
N/A	Gutter Lip Ht (in)	N/A	N/A	Gutter X Slope (%)	N/A
N/A	Painted X Walk1?	No	N/A	Painted X Walk2?	N/A
	X Walk 1 Direction	To S		X Walk 2 Direction	N/A
N/A	X Walk 1 Width (in)	N/A	N/A	X Walk 2 Width (in)	N/A
	X Walk 1 Slope (%)	0.1		X Walk 2 Slope (%)	N/A
	X Walk 1 X Slope (%)	5.1		X Walk 2 X Slope (%)	N/A

N/A	Ramp inside XWalk1?	N/A	N/A	Ramp inside XWalk2?	N/A
	Road Slope (%)	N/A	N/A	Clear Space?	N/A
	Road X Slope (%)	N/A	N/A	Clear Space to XWalk (in)	N/A
N/A	Any Obstructions?	N/A	N/A	Storm Grate/Utility Hazard?	N/A
	Obstruction Type			Storm Grate/Utility Type	
		N/A			N/A
			Yes	Surface Condition? (G/P)	Good

Remove & Replace Entire Ramp.
