# Access Compliance Report

## Public Rights-of-Way

Intersection ID: 10013227	Main Street: THE_PLAZA	Cross Street: N/A	Location: NW
ADA ID: A864B2C80267	Ramp Type: Para	Initial Pass/Fail: Pass	Overall Compliance: No
Codes/Mitigation Info/Possible Solution		Field Measurements/Component Compliance

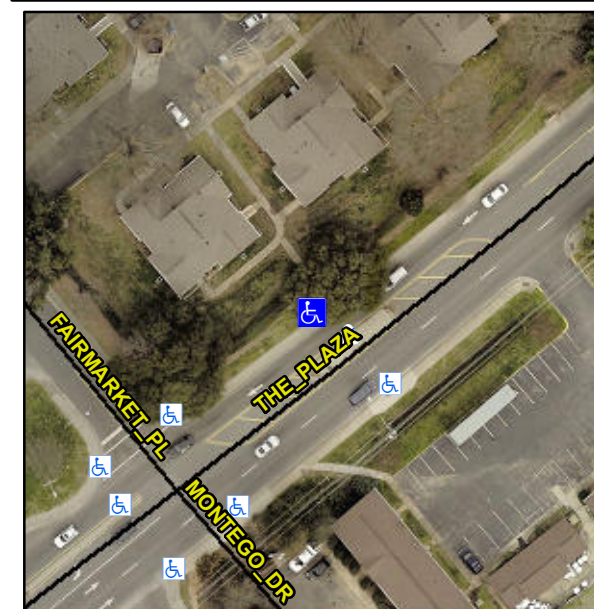
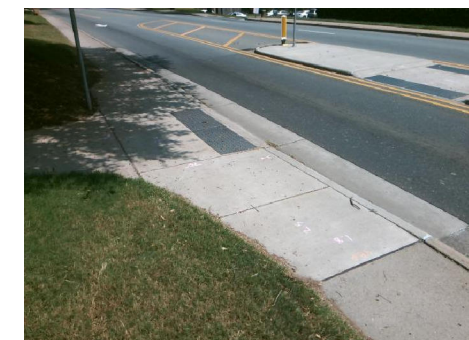
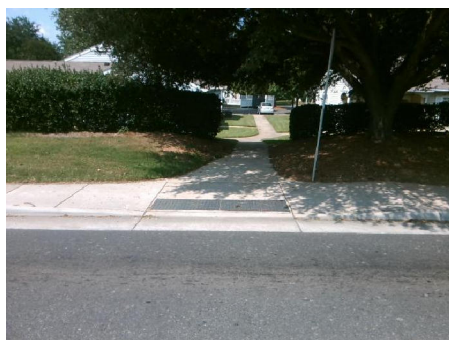
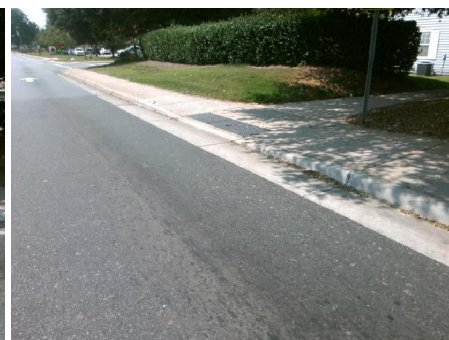
**LT RP < 5%**

**Not Found, R304.5.3, R305.2**

Compliance	Description	Data	Compliance	Description	Data
N/A	Ramp Length LT (in)	106.0	N/A	Ramp Length RT (in)	94.0
Yes	Ramp Width LT (in)	48.0	Yes	Ramp Width RT (in)	72.0
Yes	Ramp Slope LT (%)	2.5	Yes	Ramp Slope RT (%)	5.8
Yes	Ramp XSlope LT (%)	1.8	Yes	Ramp XSlope RT (%)	1.9
Yes	Landing Length (in)	70.0	Yes	DWS Provided?	Yes
Yes	Landing Width (in)	96.0	Yes	DWS Contrast?	Yes
Yes	Landing Slope (%)	2.0	Yes	DWS Length (in)	24.0
No	Landing X Slope (%)	2.7	Yes	DWS Full Width?	Yes
N/A	Landing Curb? (Y/N)	No	No	DWS Offset (in)	2.5
N/A	Shared Landing?	No			
Yes	Gutter Ponding?	No	Yes	Gutter Slope (%)	1.8
Yes	Gutter Lip Ht (in)	0.0	Yes	Gutter X Slope (%)	0.3
N/A	Painted X Walk1?	No	N/A	Painted X Walk2?	N/A
	X Walk 1 Direction	To SE		X Walk 2 Direction	N/A
N/A	X Walk 1 Width (in)	N/A	N/A	X Walk 2 Width (in)	N/A
	X Walk 1 Slope (%)	3.4		X Walk 2 Slope (%)	N/A
	X Walk 1 X Slope (%)	1.1		X Walk 2 X Slope (%)	N/A
N/A	Ramp inside XWalk1?	N/A	N/A	Ramp inside XWalk2?	N/A

Road Slope (%)	N/A	N/A	Clear Space?	Yes
	Road X Slope (%)	N/A	N/A	Clear Space to XWalk (in)	N/A
Yes	Any Obstructions?	No	Yes	Storm Grate/Utility Hazard?	No
	Obstruction Type			Storm Grate/Utility Type	
		N/A			N/A
			Yes	Surface Condition? (G/P)	Good
			Replace	Curb Slope (%)	13.8

Possible Solutions:

**Remove & Replace Entire Ramp.**
