Access Compliance Report

Public Rights-of-Way

(Curb Ramps)

Intersection ID: 3286	Main Street: MARATHON_HILL_RD	Cross Street: OLD_TIMBER_RD	Location: E
ADA ID: A86A4DBE75FC	Ramp Type: Perp	Initial Pass/Fail: Fail	Overall Compliance: No
Severity Score: 46.25			
Codes/Mitigation Info/Possible Solution		Field Measurements/Component Compliance

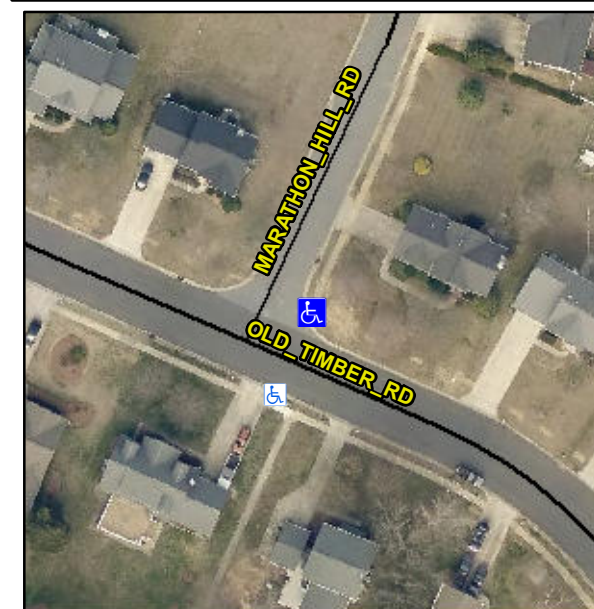
Not Found, R304.5.1, R304.2.2, R304.5.3

Compliance	Description	Data	Compliance	Description	Data
N/A	Ramp Length (in)	43.5	No	Ramp Slope (%)	8.9
No	Ramp Width (in)	41.0	No	Ramp XSlope (%)	8.0
N/A	Flare Type LT	N/A	N/A	Flare Type RT	N/A
N/A	Flare Slope LT (%)	N/A	N/A	Flare Slope RT (%)	N/A
N/A	Flare Traversable LT?	N/A	N/A	Flare Traversable RT?	N/A
N/A	Landing Length (in)	N/A	N/A	DWS Provided?	N/A
N/A	Landing Width (in)	N/A	N/A	DWS Contrast?	N/A
N/A	Landing Slope (%)	N/A	N/A	DWS Length (in)	N/A
N/A	Landing X Slope (%)	N/A	N/A	DWS Full Width?	N/A
N/A	Landing Curb? (Y/N)	N/A	N/A	DWS Offset (in)	N/A
N/A	Shared Landing?	N/A			
N/A	Gutter Ponding?	N/A	N/A	Gutter Slope (%)	N/A
N/A	Gutter Lip Ht (in)	N/A	N/A	Gutter X Slope (%)	N/A
N/A	Painted X Walk1?	No	N/A	Painted X Walk2?	N/A
	X Walk 1 Direction	To SW		X Walk 2 Direction	N/A
N/A	X Walk 1 Width (in)	N/A	N/A	X Walk 2 Width (in)	N/A
	X Walk 1 Slope (%)	2.3		X Walk 2 Slope (%)	N/A
	X Walk 1 X Slope (%)	5.9		X Walk 2 X Slope (%)	N/A

N/A	Ramp inside XWalk1?	N/A	N/A	Ramp inside XWalk2?	N/A
	Road Slope (%)	N/A	N/A	Clear Space?	N/A
	Road X Slope (%)	N/A	N/A	Clear Space to XWalk (in)	N/A
N/A	Any Obstructions?	N/A	N/A	Storm Grate/Utility Hazard?	N/A
	Obstruction Type			Storm Grate/Utility Type	
		N/A			N/A
			Yes	Surface Condition? (G/P)	Good

Possible Solutions:

Remove & Replace Entire Ramp.
