Intersection ID: 48773	Main Street: OLD_FORESTER_LN	Cross Street: SONOMA_VALLEY_DR	Location:	NE
ADA ID: A873DE2537C8	Ramp Type: PerpDiag	Initial Pass/Fail: Fail	Overall Compliance: No	Severity Score: 8.75

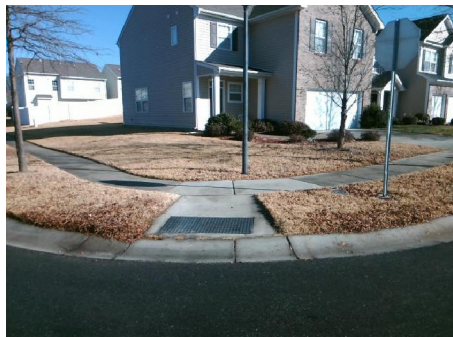
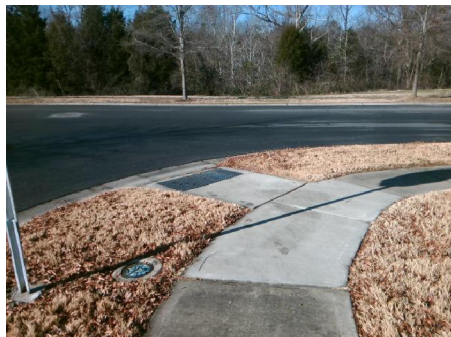
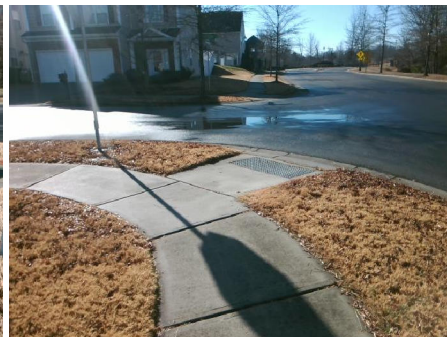
Not Found, R304.5.1

Compliance	Description	Data	Compliance	Description	Data
N/A	Ramp Length (in)	78.5	Yes	Ramp Slope (%)	5.5
No	Ramp Width (in)	47.5	Yes	Ramp XSlope (%)	1.2
N/A	Flare Type LT	N/A	N/A	Flare Type RT	N/A
N/A	Flare Slope LT (%)	N/A	N/A	Flare Slope RT (%)	N/A
N/A	Flare Traversable LT?	N/A	N/A	Flare Traversable RT?	N/A
N/A	Landing Length (in)	N/A	N/A	DWS Provided?	N/A
N/A	Landing Width (in)	N/A	N/A	DWS Contrast?	N/A
N/A	Landing Slope (%)	N/A	N/A	DWS Length (in)	N/A
N/A	Landing X Slope (%)	N/A	N/A	DWS Full Width?	N/A
N/A	Landing Curb? (Y/N)	N/A	N/A	DWS Offset (in)	N/A
N/A	Shared Landing?	N/A			
N/A	Gutter Ponding?	N/A	N/A	Gutter Slope (%)	N/A
N/A	Gutter Lip Ht (in)	N/A	N/A	Gutter X Slope (%)	N/A
N/A	Painted X Walk1?	No	N/A	Painted X Walk2?	No
	X Walk 1 Direction	To W		X Walk 2 Direction	To S
N/A	X Walk 1 Width (in)	N/A	N/A	X Walk 2 Width (in)	N/A
	X Walk 1 Slope (%)	1.9		X Walk 2 Slope (%)	1.8
	X Walk 1 X Slope (%)	1.7		X Walk 2 X Slope (%)	0.0

N/A	Ramp inside XWalk1?	N/A	N/A	Ramp inside XWalk2?	N/A
	Road Slope (%)	0.4	N/A	Clear Space?	N/A
	Road X Slope (%)	1.4	N/A	Clear Space to XWalk (in)	N/A
N/A	Any Obstructions?	N/A	N/A	Storm Grate/Utility Hazard?	N/A
	Obstruction Type			Storm Grate/Utility Type	
		N/A			N/A
			Yes	Surface Condition? (G/P)	Good

Remove & Replace Curb Ramp With Two New Directional Ramps or Equivalent.
