Access Compliance Report Public Rights-of-Way (Curb Ramps)

Intersection ID: N/A Main Street: S COLLEGE ST Cross Street: E_MARTIN_LUTHER_KING_BV Location: W **ADA ID: A87AAF98A00D** Ramp Type: PerpDiag Initial Pass/Fail: Fail **Overall Compliance: No Severity Score:** 12.5

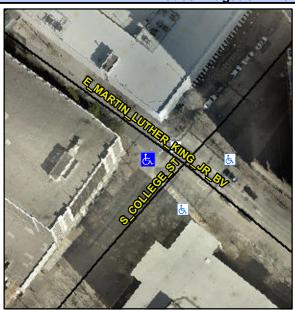
S COLLEGE ST Street 1 Name Stop Condition-Street 2 Signal Street 2 Name **E MARTIN LUTHER KING JR BLVD** Stop Condition-Street 1 Signal

Field Measurements/Component Compliance						
Compl	iance Description	Data	Compl	iance	Description	Data
N/A	Ramp Length (in)	78.0	Yes	Ramp	Slope (%)	7.1
Yes	Ramp Width (in)	96.0	No	Ramp	XSlope (%)	6.2
N/A	Flare Type LT	N/A	N/A	Flare	Type RT	N/A
N/A	Flare Slope LT (%)	N/A	N/A	Flare	Slope RT (%)	N/A
N/A	Flare Traversable LT?	N/A	N/A	Flare	Traversable RT?	N/A
N/A	Landing Length (in)	N/A	N/A	DWS	Provided?	N/A
N/A	Landing Width (in)	N/A	N/A	DWS	Contrast?	N/A
N/A	Landing Slope (%)	N/A	N/A	DWS	Length (in)	N/A
N/A	Landing X Slope (%)	N/A	N/A	DWS	Full Width?	N/A
N/A	Landing Curb? (Y/N)	N/A	N/A	DWS	Offset (in)	N/A
N/A	Shared Landing?	N/A				
N/A	Gutter Ponding?	N/A	N/A	Gutte	er Slope (%)	N/A
N/A	Gutter Lip Ht (in)	N/A	N/A	Gutte	r X Slope (%)	N/A
N/A	Painted X Walk1?	Yes	N/A	Paint	ed X Walk2?	Yes
	X Walk 1 Direction	To SE		X Wa	lk 2 Direction	To NE
N/A	X Walk 1 Width (in)	108.0	N/A	X Wa	lk 2 Width (in)	107.0
	X Walk 1 Slope (%)	1.8		X Wa	lk 2 Slope (%)	4.0

X Walk 1 X Slope (%)	6.1		X Wa	lk 2 X Slope (%)	1.2
N/A	Ramp inside XWalk1?	Yes	N/A	Ram	inside XWalk2?	Yes
	Road Slope (%)	3.2	N/A	Clear	Space?	N/A
	Road X Slope (%)	6.1	N/A	Clear	Space to XWalk (in)	N/A
N/A	Any Obstructions?	N/A	N/A	Storn	n Grate/Utility Hazard?	N/A
	Obstruction Type			Storn	n Grate/Utility Type	
		N/A				N/A
			Yes	Surfa	ce Condition? (G/P)	Good
E STATE OF THE STA

Possible Solutions: **Remove & Replace Curb Ramp With Two New Directional Ramps or** Equivalent. Surveyor Notes: N/A PROW/ADA: Not Found, R304.5.3

Total Cost: 3200.00
