Access Compliance Report

Public Rights-of-Way

(Curb Ramps)

Intersection ID: 51243	Main Street: NORTHCREST SHOPPING CENTER DR	Cross Street: W W T HARRIS BV	Location: SW
ADA ID: A8816E4E16A4	Ramp Type: Perp	Initial Pass/Fail: Fail	Overall Compliance: No
Severity Score: 22.5			
Codes/Mitigation Info/Possible Solution		Field Measurements/Component Compliance

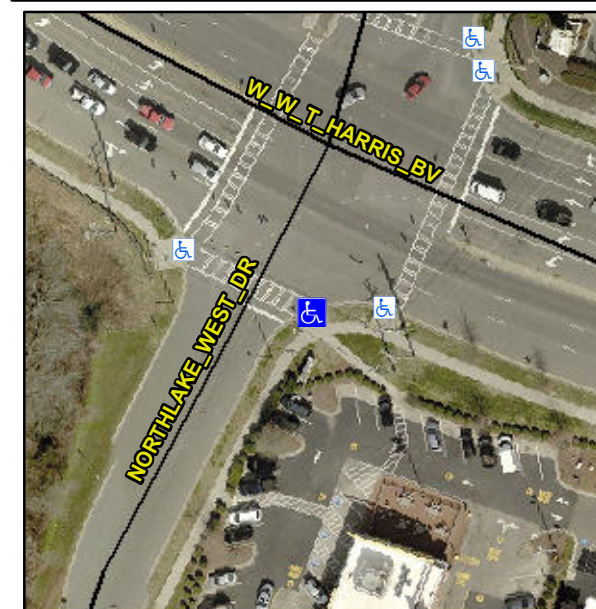
Not Found, R304.5.1, R304.2.2, R304.5.3

Compliance	Description	Data	Compliance	Description	Data
N/A	Ramp Length (in)	95.0	No	Ramp Slope (%)	8.4
No	Ramp Width (in)	42.0	No	Ramp XSlope (%)	2.7
N/A	Flare Type LT	N/A	N/A	Flare Type RT	N/A
N/A	Flare Slope LT (%)	N/A	N/A	Flare Slope RT (%)	N/A
N/A	Flare Traversable LT?	N/A	N/A	Flare Traversable RT?	N/A
N/A	Landing Length (in)	N/A	N/A	DWS Provided?	N/A
N/A	Landing Width (in)	N/A	N/A	DWS Contrast?	N/A
N/A	Landing Slope (%)	N/A	N/A	DWS Length (in)	N/A
N/A	Landing X Slope (%)	N/A	N/A	DWS Full Width?	N/A
N/A	Landing Curb? (Y/N)	N/A	N/A	DWS Offset (in)	N/A
N/A	Shared Landing?	N/A			
N/A	Gutter Ponding?	N/A	N/A	Gutter Slope (%)	N/A
N/A	Gutter Lip Ht (in)	N/A	N/A	Gutter X Slope (%)	N/A
N/A	Painted X Walk1?	Yes	N/A	Painted X Walk2?	N/A
	X Walk 1 Direction	To NW		X Walk 2 Direction	N/A
N/A	X Walk 1 Width (in)	108.0	N/A	X Walk 2 Width (in)	N/A
	X Walk 1 Slope (%)	3.5		X Walk 2 Slope (%)	N/A
	X Walk 1 X Slope (%)	1.0		X Walk 2 X Slope (%)	N/A

N/A	Ramp inside XWalk1?	Yes	N/A	Ramp inside XWalk2?	N/A
	Road Slope (%)	N/A	N/A	Clear Space?	N/A
	Road X Slope (%)	N/A	N/A	Clear Space to XWalk (in)	N/A
N/A	Any Obstructions?	N/A	N/A	Storm Grate/Utility Hazard?	N/A
	Obstruction Type			Storm Grate/Utility Type	
		N/A			N/A
			Yes	Surface Condition? (G/P)	Good

Possible Solutions:

Remove & Replace Entire Ramp.
