# Access Compliance Report

## Public Rights-of-Way

### (Curb Ramps)

| Intersection ID: 10866 | Main Street: DALTON_AV | Cross Street: PLYMOUTH_AV | Location: NE |

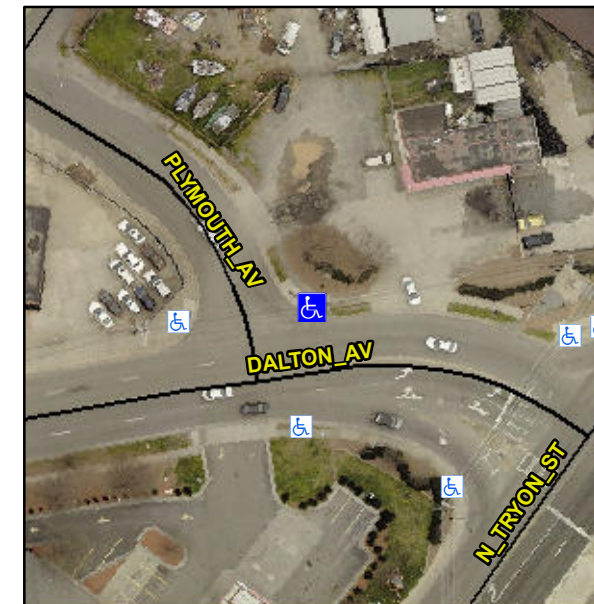
**Not Found, R304.5.3, R302.7, R302.7.2**

| Compliance | Description | Data | Compliance | Description | Data |
|---|---|---|---|---|---|
| No | Landing X Slope (%) | 2.2 | Yes | DWS Full Width? | Yes |
| No | Gutter Ponding? | Yes | Yes | Gutter Slope (%) | 1.0 |
| No | Gutter Lip Ht (in) | 1.5 | No | Gutter X Slope (%) | 2.5 |

**Remove & Replace Curb Ramp With Two New Directional Ramps or Equivalent. Remove & Replace Gutter.**
