Access Compliance Report

Public Rights-of-Way

(Curb Ramps)

Intersection ID: 10022370	Main Street: CAMILLA_DR	Cross Street: N/A	Location: SW
ADA ID: A88D9CC2F63F	Ramp Type: Directional1	Initial Pass/Fail: Fail	Overall Compliance: No
		Severity Score: 1.25

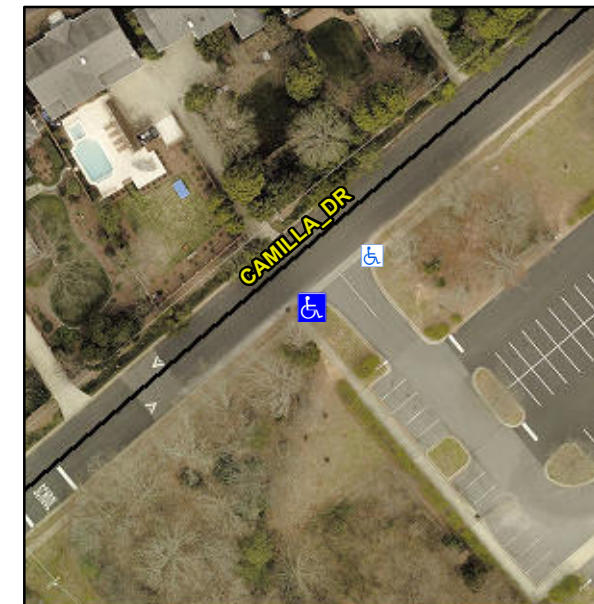
R304.5.3

Compliance	Description	Data	Compliance	Description	Data
N/A	Ramp Length (in)	61.0	N/A	Grade Break?	N/A
Yes	Ramp Width (in)	52.5	N/A	Grade Break Slope (%)	0.0
Yes	Ramp Slope (%)	2.9	N/A	Grade Break XSlope (%)	0.0
No	Ramp XSlope (%)	2.7			
N/A	Flare Type LT	N/A	N/A	Flare Type RT	N/A
N/A	Flare Slope LT (%)	N/A	N/A	Flare Slope RT (%)	0.0
N/A	Flare Traversable LT?	N/A	N/A	Flare Traversable RT?	N/A
N/A	Landing Length (in)	0.0	N/A	DWS Provided?	N/A
N/A	Landing Width (in)	0.0	N/A	DWS Contrast?	N/A
N/A	Landing Slope (%)	0.0	N/A	DWS Length (in)	N/A
N/A	Landing X Slope (%)	0.0	N/A	DWS Full Width?	N/A
N/A	Landing Curb? (Y/N)	N/A	N/A	DWS Offset LT (in)	N/A
N/A	Shared Landing?	N/A	N/A	DWS Offset RT (in)	N/A
N/A	Gutter Ponding?	0.0	N/A	Gutter Slope (%)	N/A
N/A	Gutter Lip Ht (in)	0.0	N/A	Gutter X Slope (%)	N/A
N/A	Painted X Walk1?	No		Road Slope (%)	2.7
	X Walk 1 Direction	To NE		Road X Slope (%)	2.0
	X Walk 1 Width (in)	N/A		Clear Space?	N/A

X Walk 1 Slope (%)	2.7	N/A	Clear Space to XWalk (in)	N/A
	X Walk 1 X Slope (%)	2.0	N/A	Storm Grate/Utility Hazard?	N/A
N/A	Ramp inside XWalk1?	N/A		Storm Grate/Utility Type	
N/A	Any Obstructions?	N/A			N/A
	Obstruction Type		Yes	Surface Condition? (G/P)	Good
			N/A	Curb Slope (%)	8.3

Remove & Replace Entire Ramp.
