# Access Compliance Report

## Public Rights-of-Way

### (Curb Ramps)

Intersection ID: 26515	Main Street: JOHNSTON_RD	Cross Street: PORTERFIELD_RD	Location: NE
ADA ID: A8970738795F	Ramp Type: PerpDiag	Initial Pass/Fail: Fail	Overall Compliance: No
		Severity Score: 10

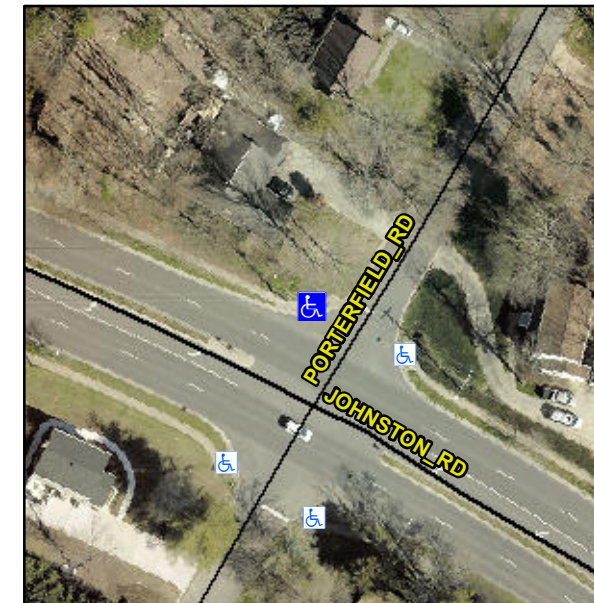
**Not Found, R304.5.1, R304.5.3**

Compliance	Description	Data	Compliance	Description	Data
N/A	Ramp Length (in)	58.0	Yes	Ramp Slope (%)	7.5
No	Ramp Width (in)	43.0	No	Ramp XSlope (%)	2.7
N/A	Flare Type LT	N/A	N/A	Flare Type RT	N/A
N/A	Flare Slope LT (%)	N/A	N/A	Flare Slope RT (%)	N/A
N/A	Flare Traversable LT?	N/A	N/A	Flare Traversable RT?	N/A
N/A	Landing Length (in)	N/A	N/A	DWS Provided?	N/A
N/A	Landing Width (in)	N/A	N/A	DWS Contrast?	N/A
N/A	Landing Slope (%)	N/A	N/A	DWS Length (in)	N/A
N/A	Landing X Slope (%)	N/A	N/A	DWS Full Width?	N/A
N/A	Landing Curb? (Y/N)	N/A	N/A	DWS Offset (in)	N/A
N/A	Shared Landing?	N/A			
N/A	Gutter Ponding?	N/A	N/A	Gutter Slope (%)	N/A
N/A	Gutter Lip Ht (in)	N/A	N/A	Gutter X Slope (%)	N/A
N/A	Painted X Walk1?	No	N/A	Painted X Walk2?	No
	X Walk 1 Direction	To SW		X Walk 2 Direction	To SE
N/A	X Walk 1 Width (in)	N/A	N/A	X Walk 2 Width (in)	N/A
	X Walk 1 Slope (%)	5.5		X Walk 2 Slope (%)	2.4
	X Walk 1 X Slope (%)	2.3		X Walk 2 X Slope (%)	4.3

N/A	Ramp inside XWalk1?	N/A	N/A	Ramp inside XWalk2?	N/A
	Road Slope (%)	2.9	N/A	Clear Space?	N/A
	Road X Slope (%)	4.5	N/A	Clear Space to XWalk (in)	N/A
N/A	Any Obstructions?	N/A	N/A	Storm Grate/Utility Hazard?	N/A
	Obstruction Type			Storm Grate/Utility Type	
		N/A			N/A
			Yes	Surface Condition? (G/P)	Good

**Remove & Replace Curb Ramp With Two New Directional Ramps or Equivalent.**
