# Access Compliance Report

## Public Rights-of-Way

### (Curb Ramps)

Intersection ID: 9172	Main Street: E_CRAIGHEAD_RD	Cross Street: N_TRYON_ST	Location: SE
ADA ID: A89CD5EF2F79	Ramp Type: Perp	Initial Pass/Fail: Fail	Overall Compliance: No
Severity Score: 10			
Codes/Mitigation Info/Possible Solution		Field Measurements/Component Compliance

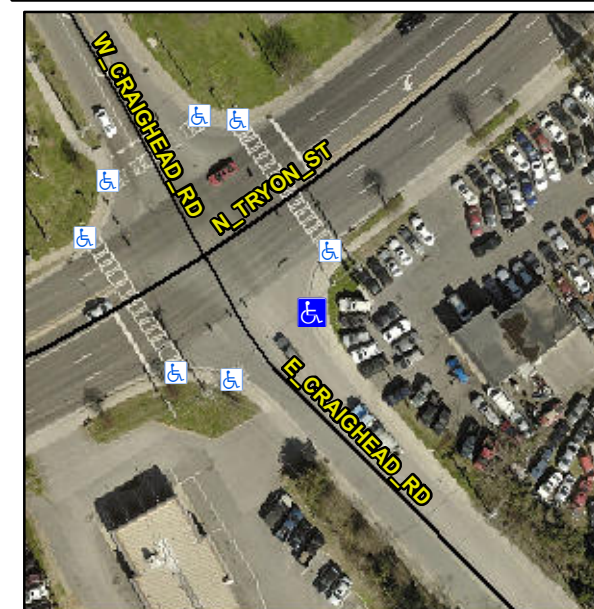
**Not Found, R304.5.1, R304.5.3**

Compliance	Description	Data	Compliance	Description	Data
N/A	Ramp Length (in)	102.5	Yes	Ramp Slope (%)	5.5
No	Ramp Width (in)	41.5	No	Ramp XSlope (%)	3.7
N/A	Flare Type LT	N/A	N/A	Flare Type RT	N/A
N/A	Flare Slope LT (%)	N/A	N/A	Flare Slope RT (%)	N/A
N/A	Flare Traversable LT?	N/A	N/A	Flare Traversable RT?	N/A
N/A	Landing Length (in)	N/A	N/A	DWS Provided?	N/A
N/A	Landing Width (in)	N/A	N/A	DWS Contrast?	N/A
N/A	Landing Slope (%)	N/A	N/A	DWS Length (in)	N/A
N/A	Landing X Slope (%)	N/A	N/A	DWS Full Width?	N/A
N/A	Landing Curb? (Y/N)	N/A	N/A	DWS Offset (in)	N/A
N/A	Shared Landing?	N/A			
N/A	Gutter Ponding?	N/A	N/A	Gutter Slope (%)	N/A
N/A	Gutter Lip Ht (in)	N/A	N/A	Gutter X Slope (%)	N/A
N/A	Painted X Walk1?	Yes	N/A	Painted X Walk2?	N/A
	X Walk 1 Direction	To SW		X Walk 2 Direction	N/A
N/A	X Walk 1 Width (in)	84.5	N/A	X Walk 2 Width (in)	N/A
	X Walk 1 Slope (%)	0.6		X Walk 2 Slope (%)	N/A
	X Walk 1 X Slope (%)	2.2		X Walk 2 X Slope (%)	N/A

N/A	Ramp inside XWalk1?	Yes	N/A	Ramp inside XWalk2?	N/A
	Road Slope (%)	N/A	N/A	Clear Space?	N/A
	Road X Slope (%)	N/A	N/A	Clear Space to XWalk (in)	N/A
N/A	Any Obstructions?	N/A	N/A	Storm Grate/Utility Hazard?	N/A
	Obstruction Type			Storm Grate/Utility Type	
		N/A			N/A
		Yes		Surface Condition? (G/P)	Good

**Remove & Replace Entire Ramp.**
