Access Compliance Report

Public Rights-of-Way

(Curb Ramps)

Intersection ID: 44823	Main Street: SPRING_OAK_DR	Cross Street: GOLDEN_RIDGE_LN	Location: SE
ADA ID: A8A13A4BC5DF	Ramp Type: PerpDiag	Initial Pass/Fail: Fail	Overall Compliance: No
Severity Score: 10			
Codes/Mitigation Info/Possible Solution		Field Measurements/Component Compliance

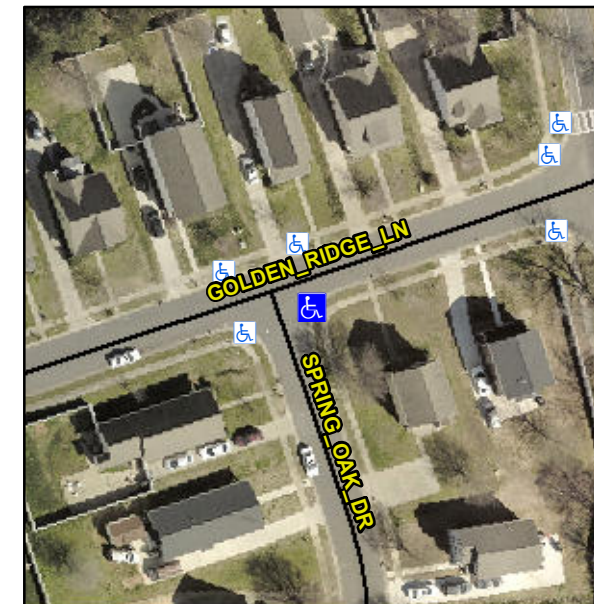
Compliance	Description	Data	Compliance	Description	Data
N/A	Ramp Length (in)	48.0	Yes	Ramp Slope (%)	5.2
No	Ramp Width (in)	40.0	No	Ramp XSlope (%)	2.3
N/A	Flare Type LT	N/A	N/A	Flare Type RT	N/A
N/A	Flare Slope LT (%)	N/A	N/A	Flare Slope RT (%)	N/A
N/A	Flare Traversable LT?	N/A	N/A	Flare Traversable RT?	N/A
N/A	Landing Length (in)	N/A	N/A	DWS Provided?	N/A
N/A	Landing Width (in)	N/A	N/A	DWS Contrast?	N/A
N/A	Landing Slope (%)	N/A	N/A	DWS Length (in)	N/A
N/A	Landing X Slope (%)	N/A	N/A	DWS Full Width?	N/A
N/A	Landing Curb? (Y/N)	N/A	N/A	DWS Offset (in)	N/A
N/A	Shared Landing?	N/A			
N/A	Gutter Ponding?	N/A	N/A	Gutter Slope (%)	N/A
N/A	Gutter Lip Ht (in)	N/A	N/A	Gutter X Slope (%)	N/A
N/A	Painted X Walk1?	No	N/A	Painted X Walk2?	No
	X Walk 1 Direction	To N		X Walk 2 Direction	To W
N/A	X Walk 1 Width (in)	N/A	N/A	X Walk 2 Width (in)	N/A
	X Walk 1 Slope (%)	3.5		X Walk 2 Slope (%)	3.8
	X Walk 1 X Slope (%)	3.6		X Walk 2 X Slope (%)	6.0

N/A	Ramp inside XWalk1?	N/A	N/A	Ramp inside XWalk2?	N/A
	Road Slope (%)	0.6	N/A	Clear Space?	N/A
	Road X Slope (%)	3.8	N/A	Clear Space to XWalk (in)	N/A
N/A	Any Obstructions?	N/A	N/A	Storm Grate/Utility Hazard?	N/A
	Obstruction Type			Storm Grate/Utility Type	
		N/A			N/A
			Yes	Surface Condition? (G/P)	Good

Possible Solutions:

Remove & Replace Curb Ramp With Two New Directional Ramps or Equivalent.
