# Access Compliance Report

## Public Rights-of-Way

### (Curb Ramps)

Intersection ID: 20760	Main Street: SHARON_RD	Cross Street: SHARON_VIEW_RD	Location: SW
ADA ID: A8A178480870	Ramp Type: BlendTrans2	Initial Pass/Fail: Fail	Overall Compliance: No
		Severity Score: 35

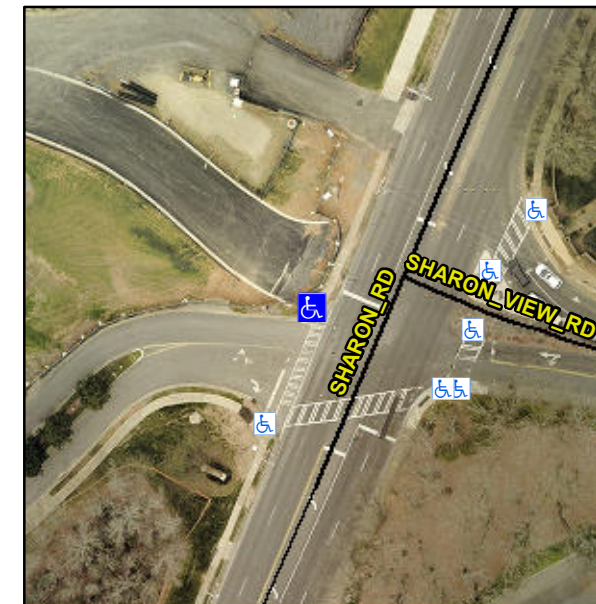
Compliance	Description	Data	Compliance	Description	Data
N/A	Ramp Length (in)	96.0	Yes	BlendTrans Slope (%)	0.8
No	Ramp Width (in)	30.0	Yes	BlendTrans XSlope (%)	1.9
N/A	Flare Type LT	N/A	N/A	Flare Type RT	N/A
N/A	Flare Slope LT (%)	N/A	N/A	Flare Slope RT (%)	N/A
N/A	Flare Traversable LT?	N/A	N/A	Flare Traversable RT?	N/A
N/A	Landing Length (in)	N/A	N/A	DWS Provided?	N/A
N/A	Landing Width (in)	N/A	N/A	DWS Contrast?	N/A
N/A	Landing Slope (%)	N/A	N/A	DWS Length (in)	N/A
N/A	Landing X Slope (%)	N/A	N/A	DWS Full Width?	N/A
N/A	Landing Curb? (Y/N)	N/A	N/A	DWS Offset (in)	N/A
N/A	Shared Landing?	N/A			
N/A	Gutter Ponding?	N/A	N/A	Gutter Slope (%)	N/A
N/A	Gutter Lip Ht (in)	N/A	N/A	Gutter X Slope (%)	N/A
N/A	Painted X Walk1?	Yes	N/A	Painted X Walk2?	No
	X Walk 1 Direction	To SW		X Walk 2 Direction	To E
	X Walk 1 Width (in)	66.0		X Walk 2 Width (in)	N/A
	X Walk 1 Slope (%)	1.7		X Walk 2 Slope (%)	3.8
	X Walk 1 X Slope (%)	1.5		X Walk 2 X Slope (%)	0.1

N/A	Ramp inside XWalk1?	No	N/A	Ramp inside XWalk2?	N/A
	Road Slope (%)	0.1		Clear Space?	N/A
	Road X Slope (%)	1.6	N/A	Clear Space to XWalk (in)	N/A
N/A	Any Obstructions?	N/A	N/A	Storm Grate/Utility Hazard?	N/A
	Obstruction Type			Storm Grate/Utility Type	
		N/A			N/A
			Yes	Surface Condition? (G/P)	Good
			No	Curb Slope (%)	15.9

**Remove & Replace Curb Ramp With Two New Directional Ramps or Equivalent. Restripe Crosswalk.**
